FIELD CASE STUDY: I-ROD® 13 YEARS AFTER INSTALLATION

How does I-Rod hold up after 13 years offshore?

The following images were recorded in 2002 during a routine topside inspection of the first offshore structure where the I-Rod system was specified for new construction. The total added cost

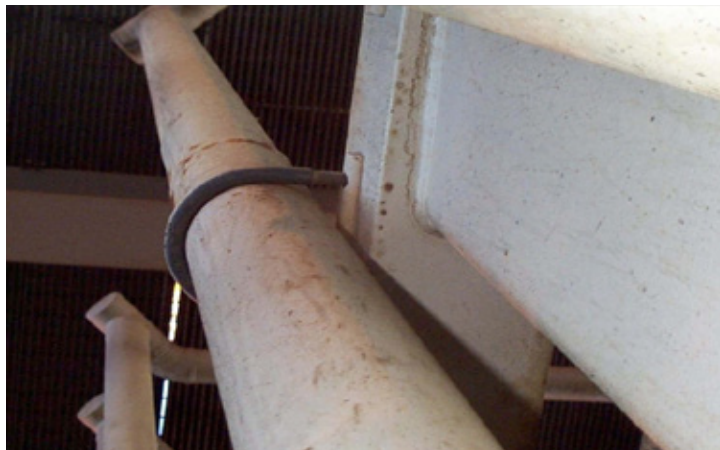
KEEPING IT FLOWING

A typical Nu-Bolt on a vertical section of a flowline.

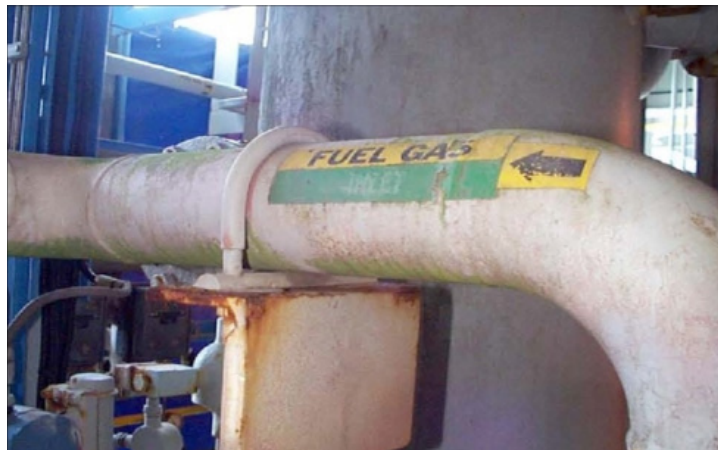
CONSTANTLY WET

This fuel gas line is always wet (the green coloration is mold) and the beam paint system has failed, but no corrosion has occurred at the pipe support.

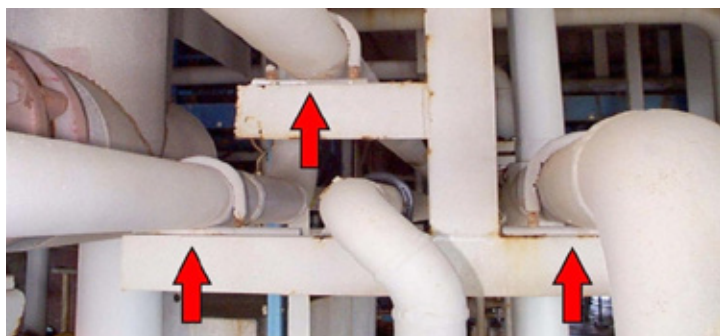
MAKING A POINT

More Nu-Bolts are pointed out; no crevice corrosion has occurred.

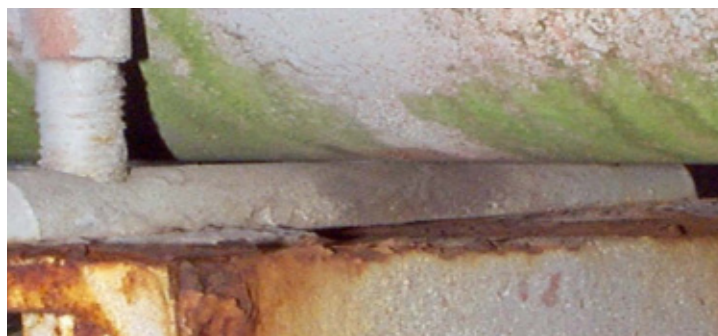
A CLOSER LOOK

Here's a closer look at the pipe support shown in the top photo above.

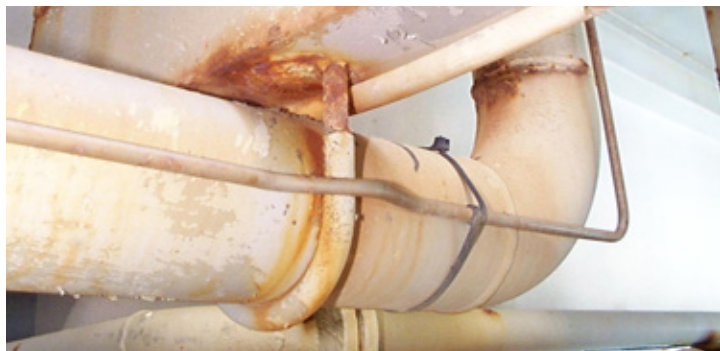
LOOKS WORSE THAN IT IS

Another instance where the paint has failed but there's no crevice corrosion.

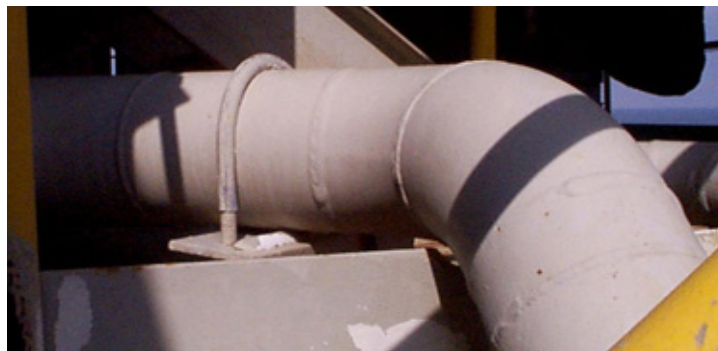
STILL IN GOOD SHAPE

The pipe remains well-preserved despite the harsh offshore environment.

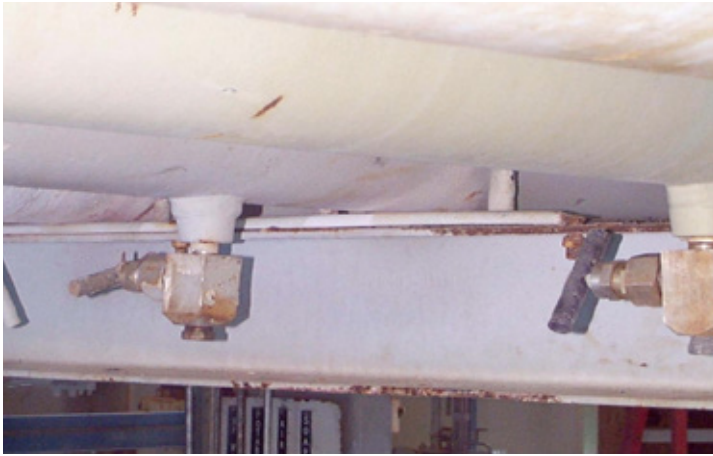
HOLDING UP WELL

I-Rod was used to dress beams beneath multiple pipes. There's no crevice corrosion.

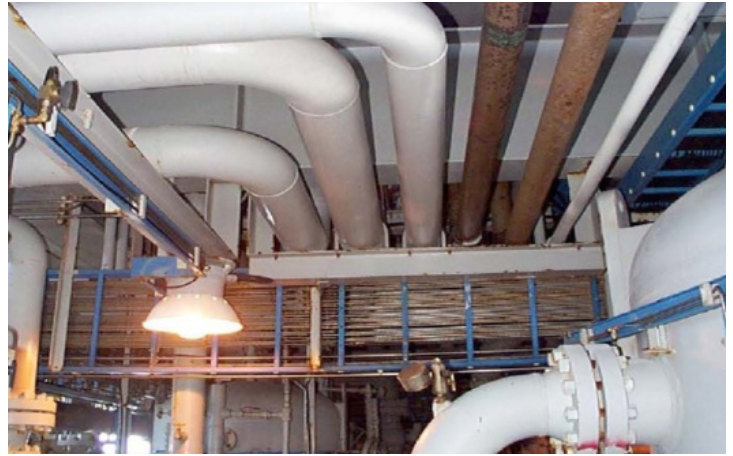
WELL-DRESSED SUPPORTS

More beam dressing on a typical pipe rack. This is 1" I-Rod.

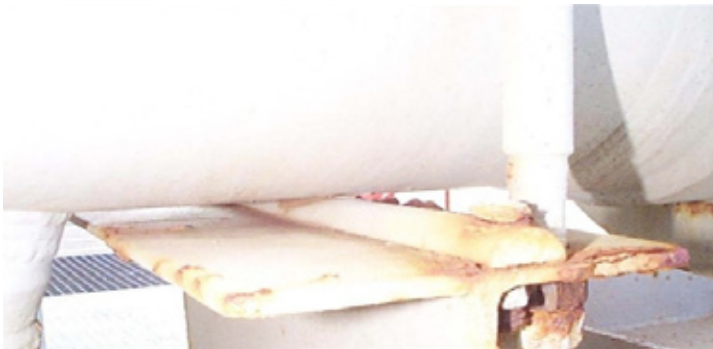
THE PIG'S PATH

A closer shot of the area beneath the assembly shown below:.

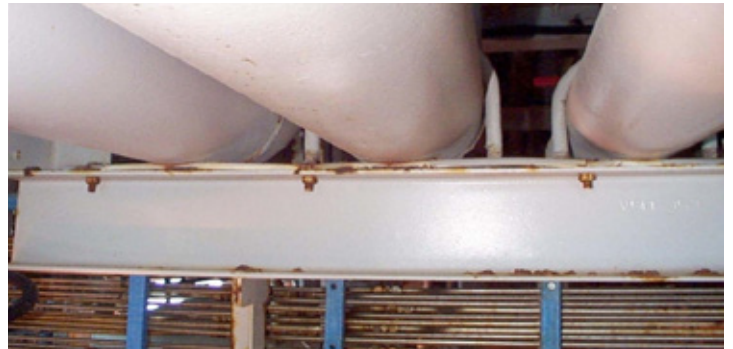
A CLOSER LOOK

Here's a closer look at the pipe support shown in the top photo above.

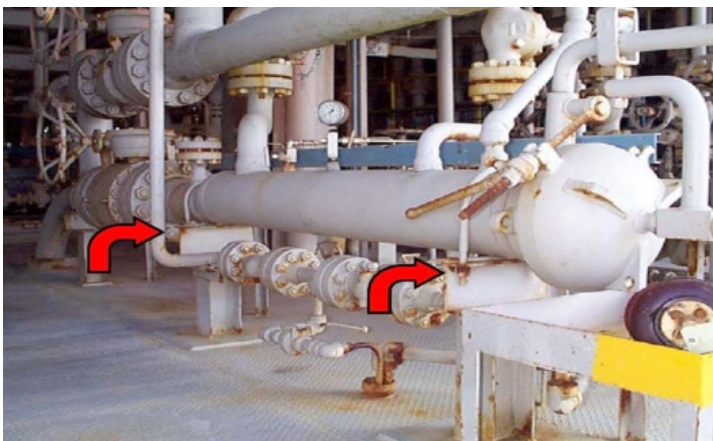
EVERYTHING'S PROTECTED

I-Rod installed under pig launch/receive barrel bolted to support beams.

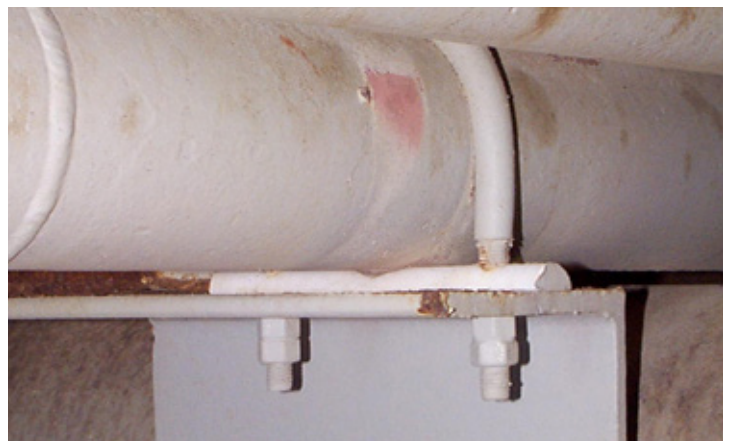
TEST OF TIME

This Nu-Bolt never corroded, but has picked up a coat of paint over the years.

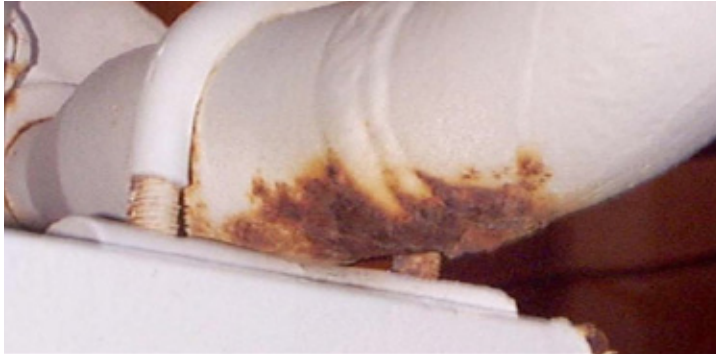
DRIP POINT (ELL CORROSION).

Crevice corrosion at the support is less than on girth weld.
Without I-Rod, this would have been a failure point.

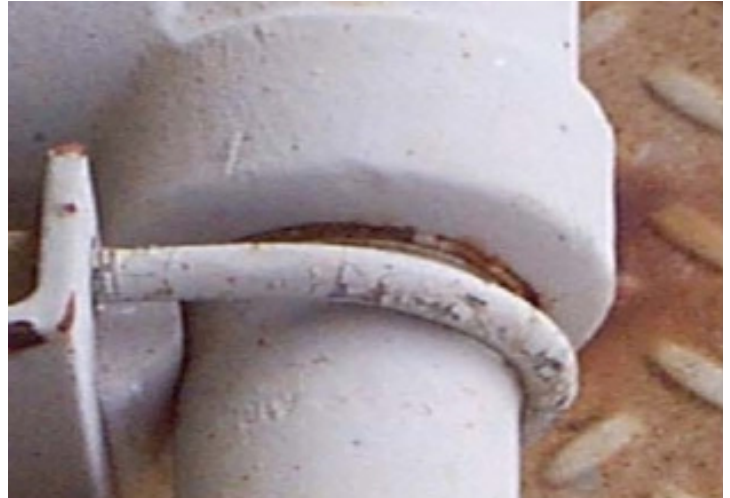
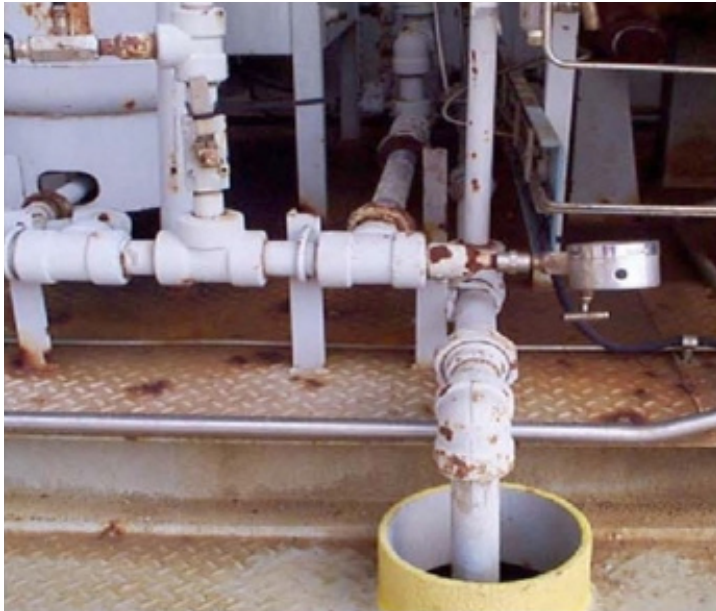
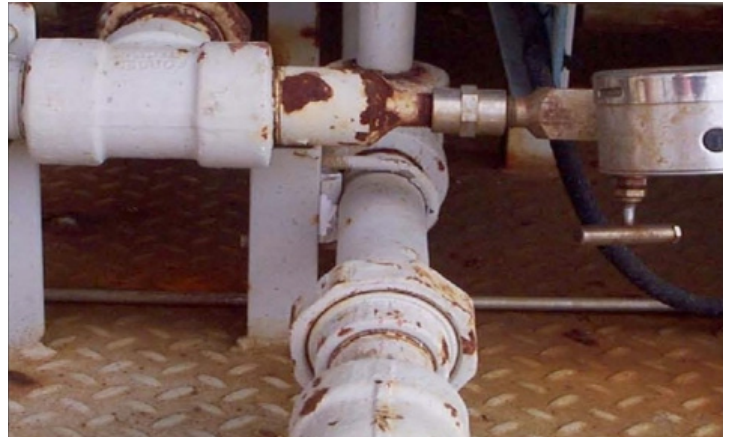
SMALL PIPES, BIG HEADACHE

I-Rod is particularly effective on small-diameter screwed piping, which has the highest maintenance cost per square foot on the platform. This smaller piping is shown in the three adjoining photos.

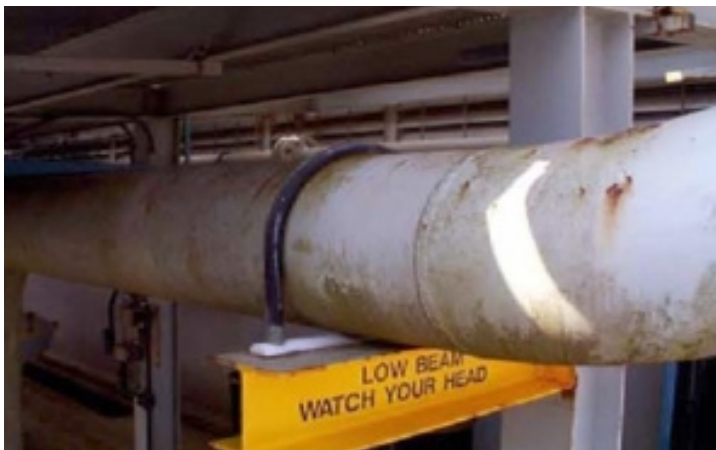
LOW BEAM, HIGH RISK

Another pipe that stays wet, as evidenced by the mold and mildew on its surface.

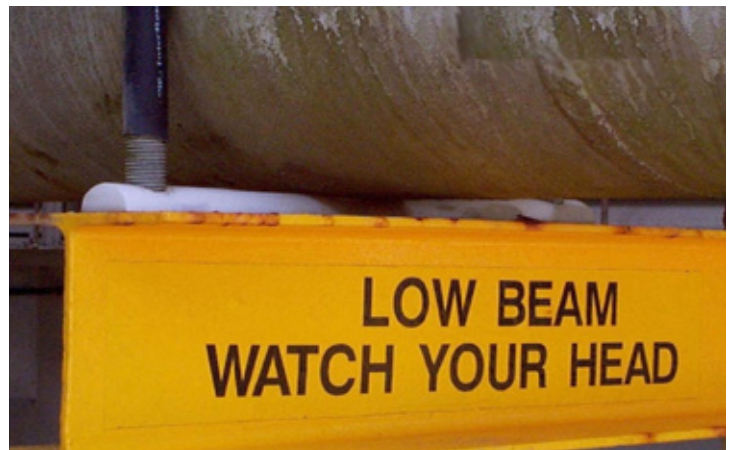
SAVED BY I-ROD

A close-up of the support at left shows why the wet pipe remained in good condition.
