FIELD CASE STUDY: I-ROD® 13 YEARS AFTER INSTALLATION

How does I-Rod hold up after 13 years offshore?

The following images were recorded in 2002 during a routine topside inspection of the first offshore structure where the I-Rod system was specified for new construction. The total added cost

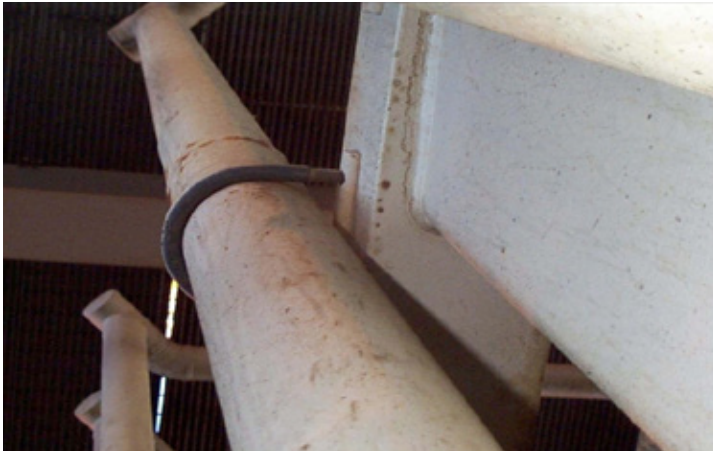
KEEPING IT FLOWING
A typical Nu-Bolt on a vertical section of a flowline.

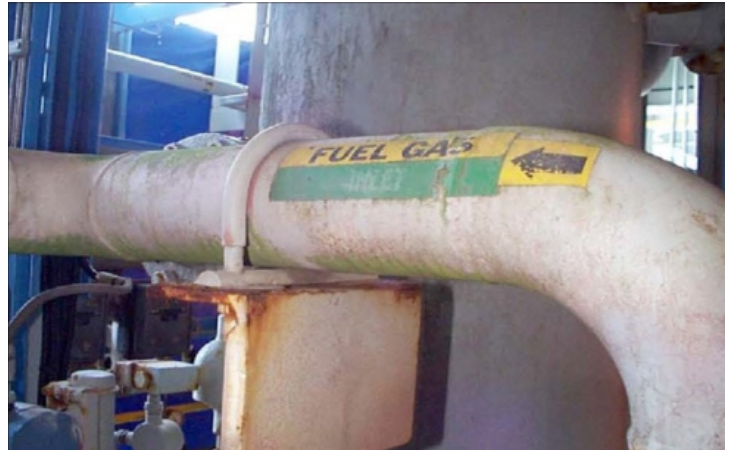
CONSTANTLY WET
This fuel gas line is always wet (the green coloration is mold) and the beam paint system has failed, but no corrosion has occurred at the pipe support..

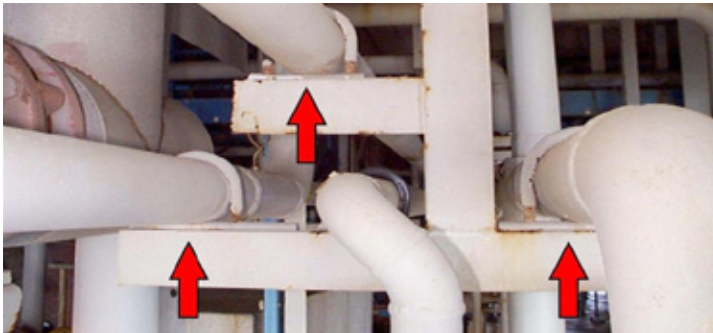
MAKING A POINT
More Nu-Bolts are pointed out; no crevice corrosion has occurred.

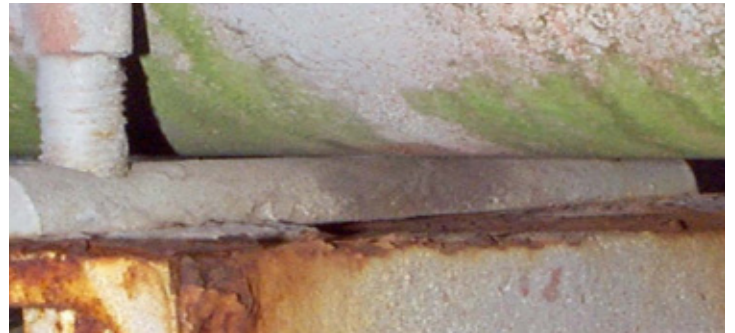
A CLOSER LOOK
Here's a closer look at the pipe support shown in the top photo above...

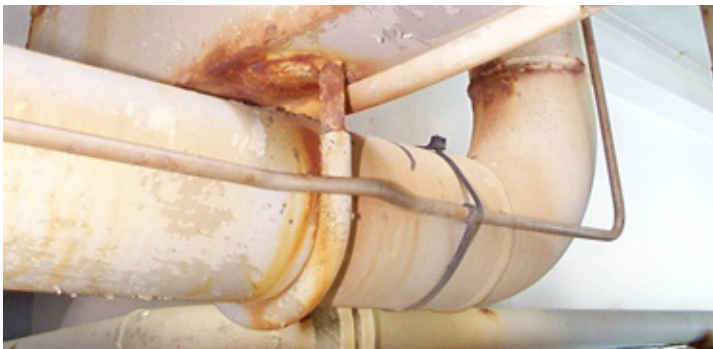
LOOKS WORSE THAN IT IS
Another instance where the paint has failed but there's no crevice corrosion.

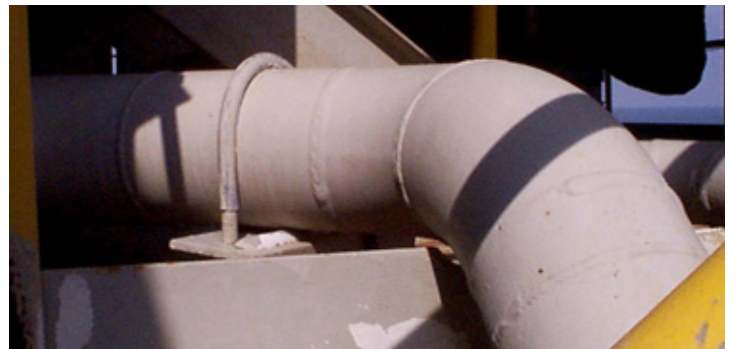
STILL IN GOOD SHAPE
The pipe remains well-preserved despite the harsh offshore environment.

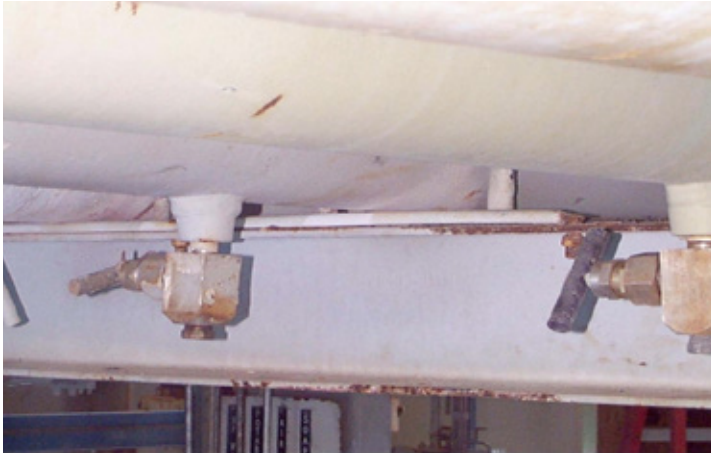
HOLDING UP WELL
I-Rod was used to dress beams beneath multiple pipes. There's no crevice corrosion.

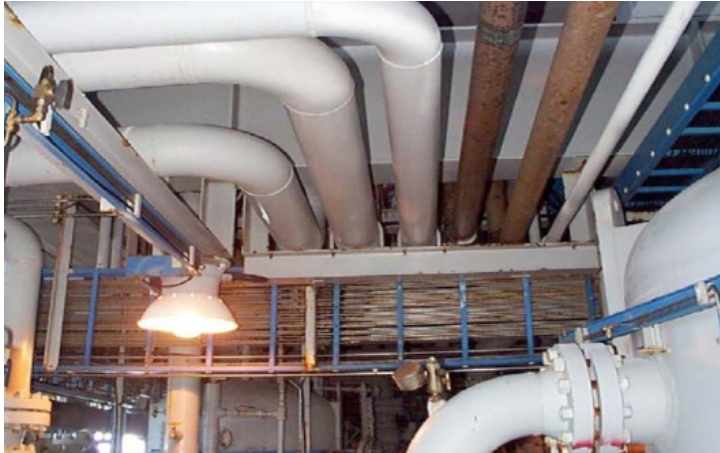
WELL-DRESSED SUPPORTS
More beam dressing on a typical pipe rack. This is 1" I-Rod.

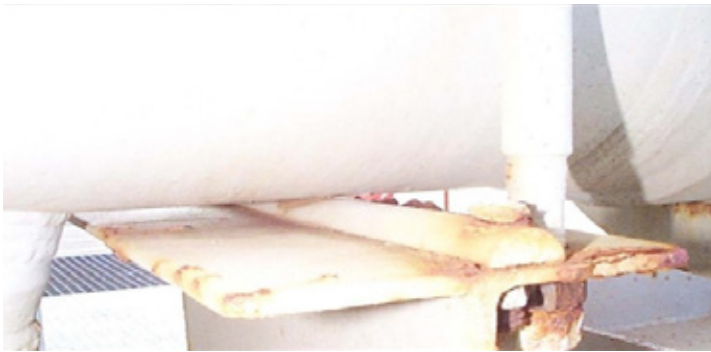
THE PIG'S PATH
A closer shot of the area beneath the assembly shown below..

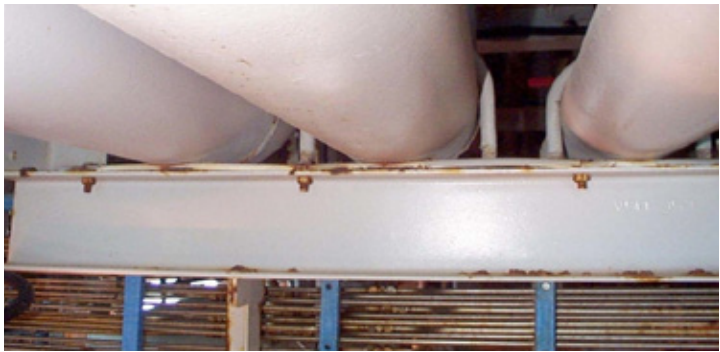
A CLOSER LOOK
Here's a closer look at the pipe support shown in the top photo above.

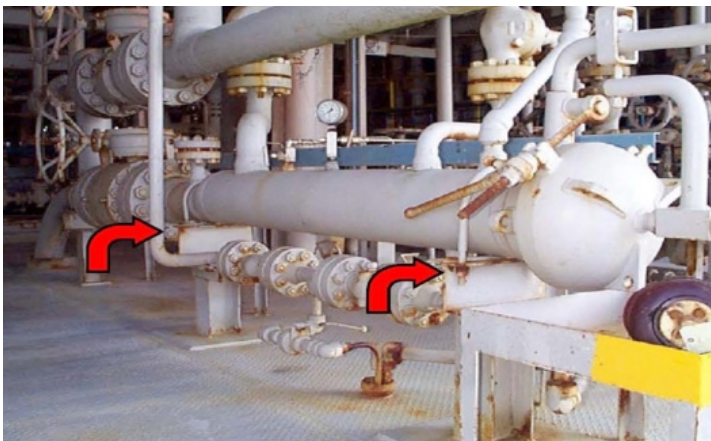
EVERYTHING'S PROTECTED
I-Rod installed under pig launch/receive barrel bolted to support beams.

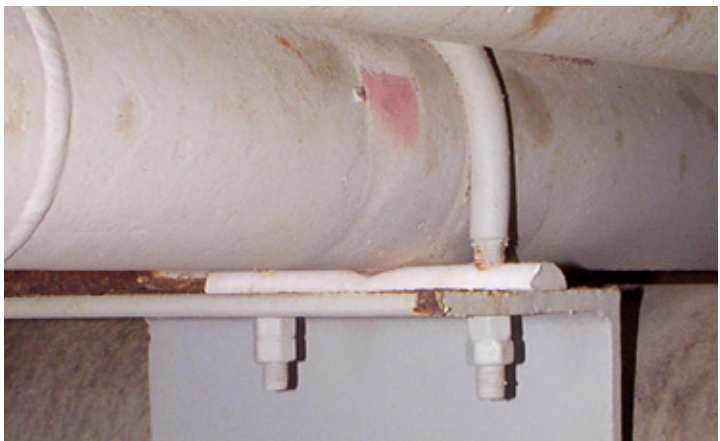
TEST OF TIME
This Nu-Bolt never corroded, but has picked up a coat of paint over the years.

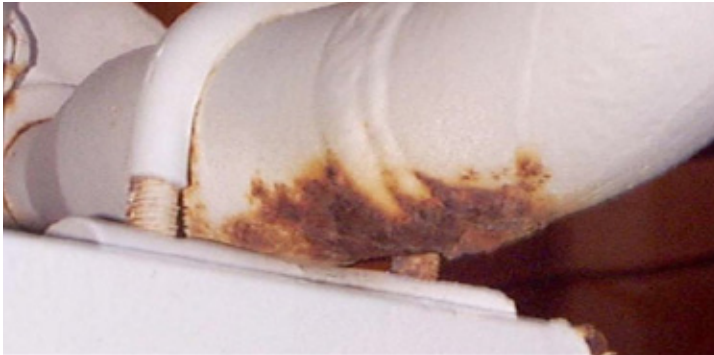
DRIP POINT (ELL CORROSION).
Crevice corrosion at the support is less than on girth weld.
Without I-Rod, this would have been a failure point.

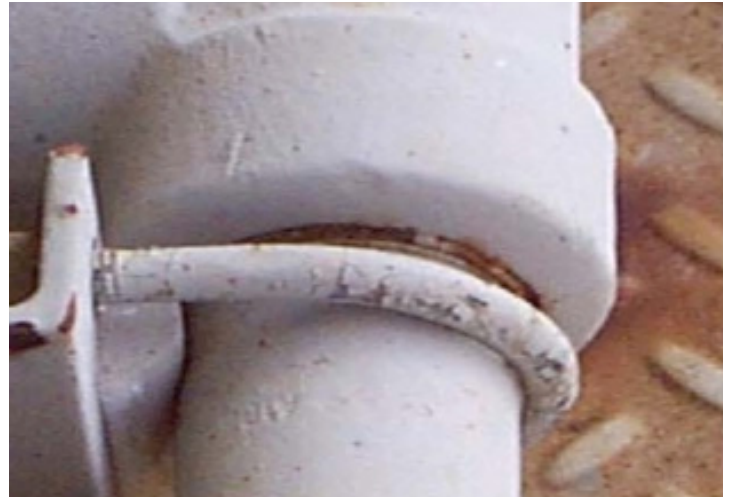
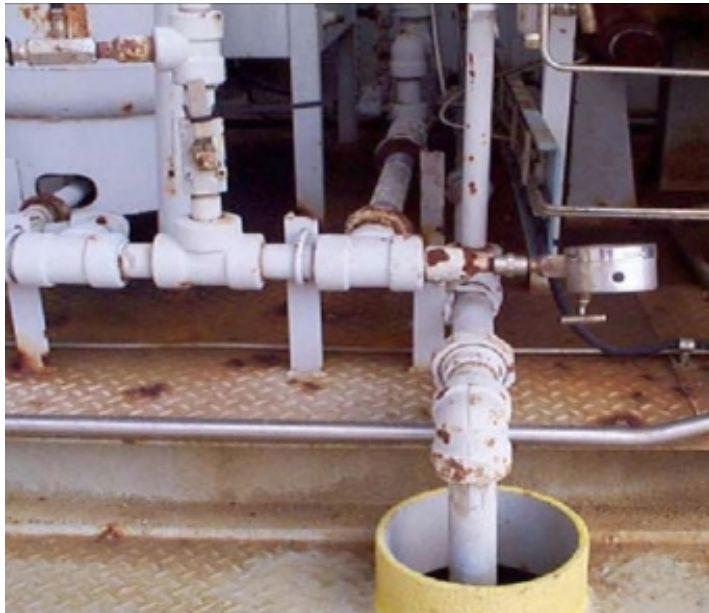
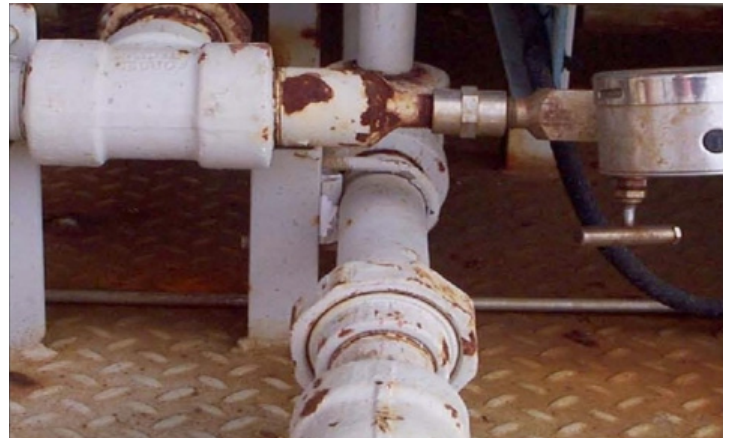
SMALL PIPES, BIG HEADACHE
I-Rod is particularly effective on small-diameter screwed piping, which has the highest maintenance cost per square foot on the platform. This smaller piping is shown in the three adjoining photos.

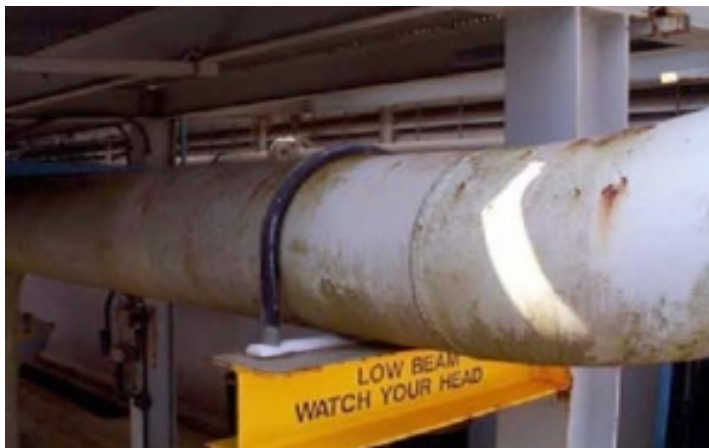
LOW BEAM, HIGH RISK
Another pipe that stays wet, as evidenced by the mold and mildew on its surface.

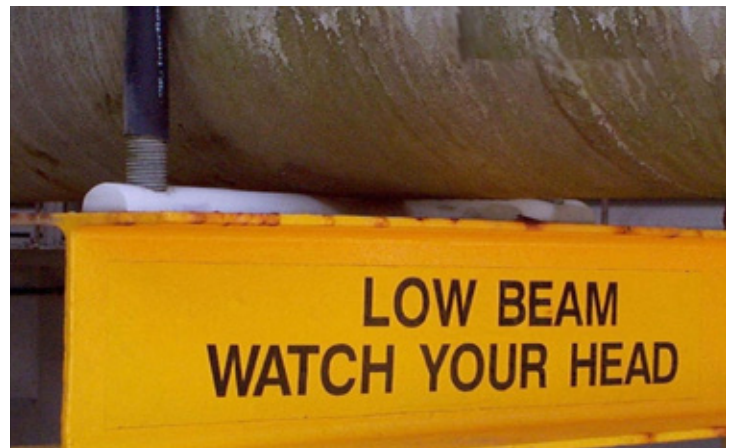
SAVED BY I-ROD
A close-up of the support at left shows why the wet pipe remained in good condition.
