CORROSION SURVEY OF SURF RANCH FACILITY: LEMOORE, CALIFORNIA

Deepwater performed a corrosion assessment of metallic structures in and around a California artificial wave pool.

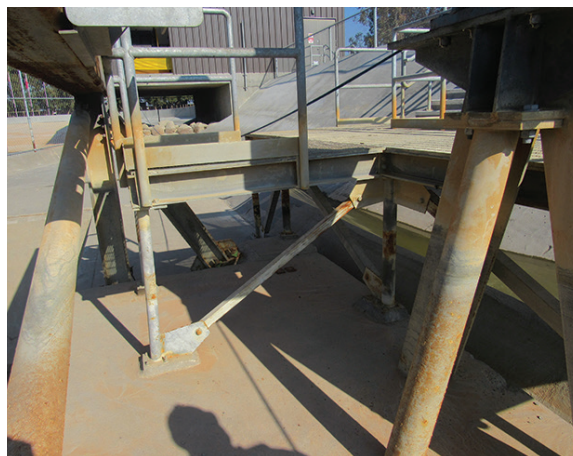
TREATED WATER NOT SUCH A TREAT
Chemicals that were used to keep the water clear may have hastened corrosion.

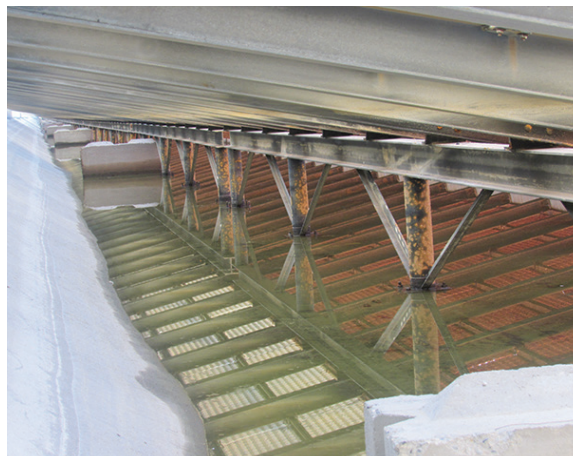
CORROSION CHECK-UP
Technicians took pitting measurements and checked for electrical continuity.
