DEEPWATER

HYDROGEN EMBRITTLEMENT STUDY ON AN INCONEL GASKET IN A CLAMP CONNECTOR

Deepwater laboratory testing to determine if CP current was reaching internal gasket, possibly leading to embrittlement.

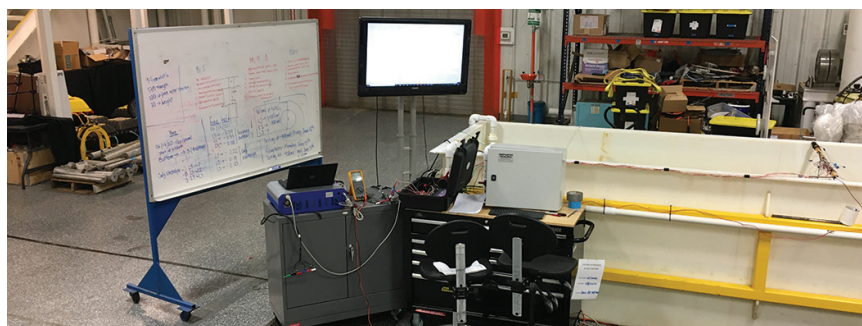
UNDERGOING SOME TESTS
A view of the data logger used to determine the amount of CP, if any, that was reaching the Inconel gasket.

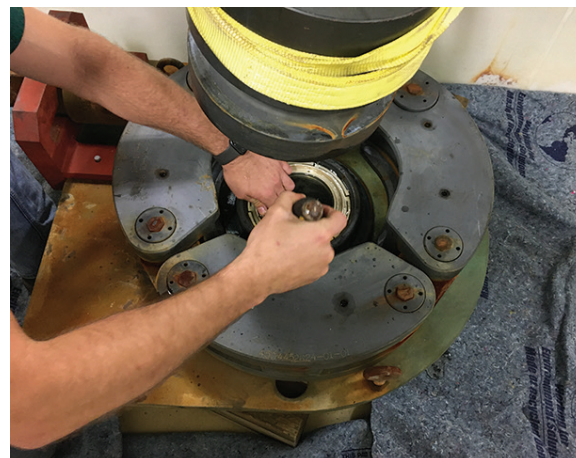
CLAMP CONNECTOR'S CATHODIC CONUNDRUM
Searching for the cause and effect of CP on a subsea 725-alloy gasket.

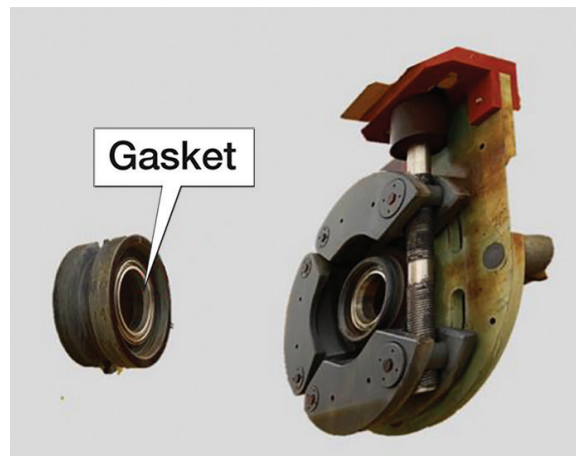
WHERE THE PROBLEM IS
The inboard connector (left) and outboard hub and clamp assembly (right).

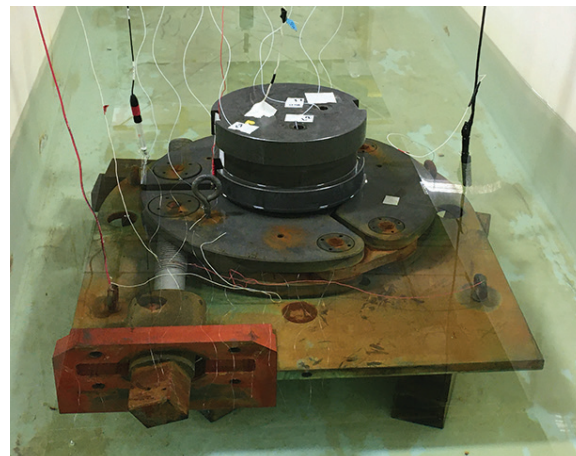
GETTING TO THE BOTTOM OF IT
Multiple tests were run in one of Deepwater's test tanks.
