DEEPWATER

DEEPWATER OVERSEES DOCK ANODE INSTALLATION: BEAUMONT ENTERPRISE MARINE TERMINAL

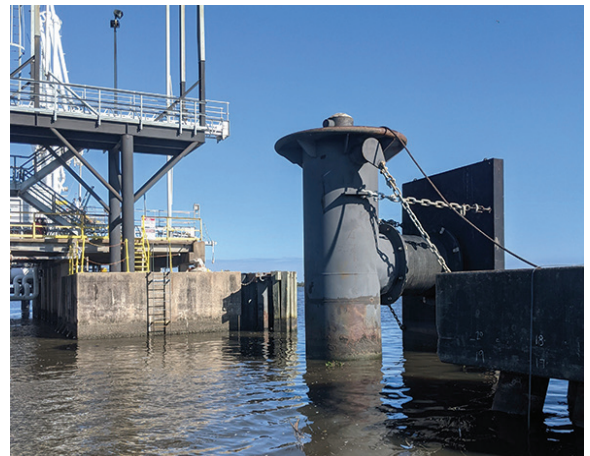
SHALLOW WATER

The water level at several dolphins was shallower than expected. For these piles, the prescribed anode was cut in half, sheet metal brackets were designed and welded onto the dolphin, and then the total anode material was installed.

Some anodes had to be modified where water was shallower than expected..

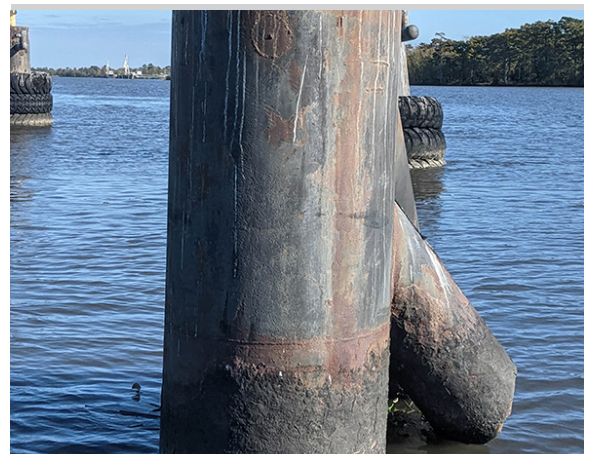
PILING ON MORE CP

Additional continuity cables installed at the North Dock were designed to create low-resistance routes for the land-side ICCP system to provide CP current to the near-dock piles, specifically the cluster of piles south of the dock structure. A second set of continuity cables were installed north of the dock to provide additional CP to the piles north of the dock.

Some pilings required continuity cables to utilize existing land-side ICCP.
