## CORROSION SURVEY OF STEEL SHEET PILES IN BUFFALO BAYOU: HOUSTON, TEXAS

## Condition of structural steel piles evaluated in downtown Houston waterway.

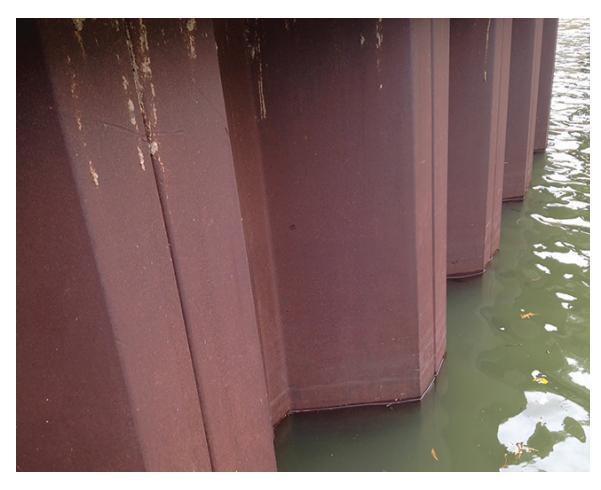
MILES OF PILES The CP survey found them mostly unprotected.

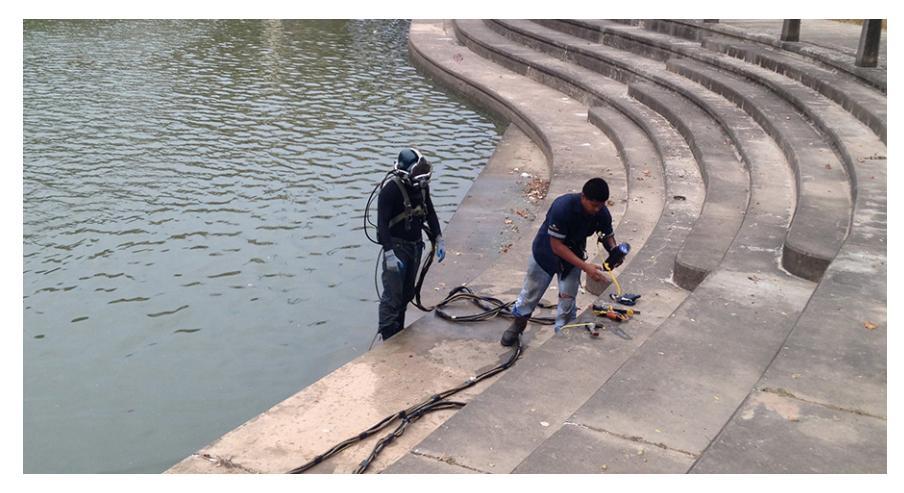
TROUBLE BELOW A diver using a Polatrak® CP Gun™ found multiple discontinuities along the sheet pile walls.

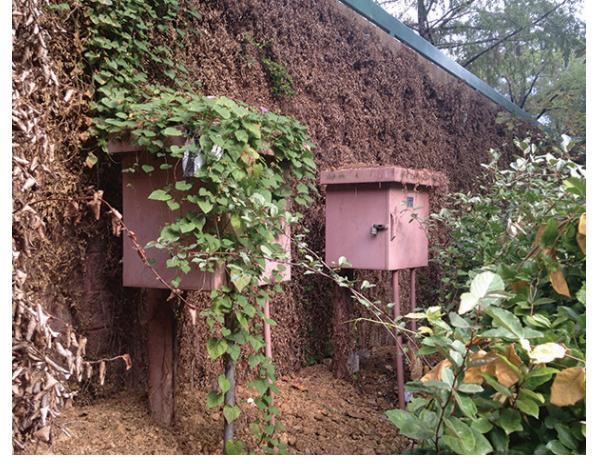
TRANSFORMER RECTIFIERS Six of the seven TRs from the original ICCP system were still functioning
