**CORROSION AT PIPE SUPPORTS
CAUSES & SOLUTIONS**

Jim Britton

**InterResources Inc.
6830, North Eldridge Parkway
Houston, TX. 77041
U.S.A.**

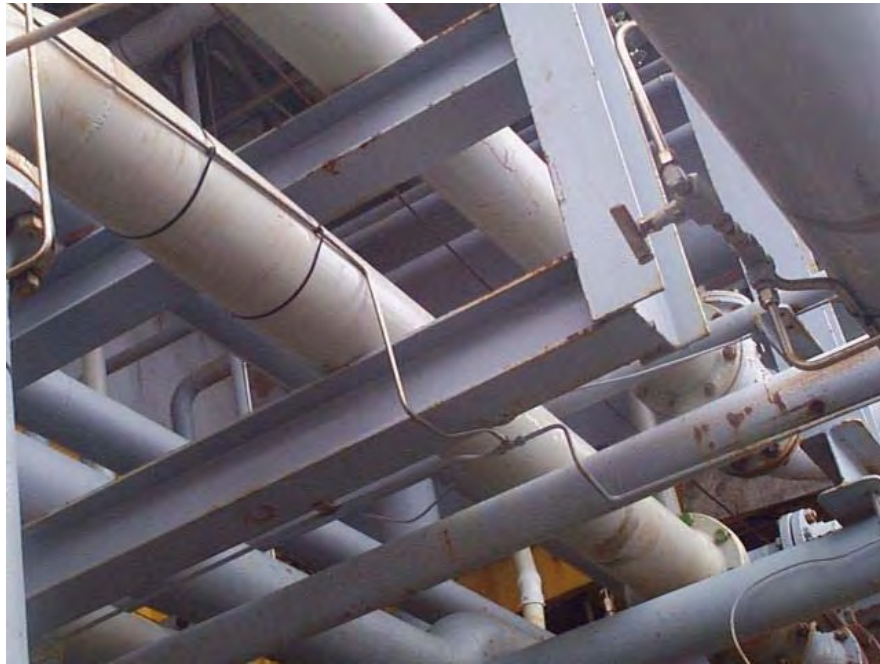
Figure 1. Typical I-Beam Pipe Support

Pipe is rested on or secured to a support member usually consisting of a standard structural shape. I-beam, wide flange beam, angle, channel etc. The pipe may be secured to this member with a stabilizing U-bolt. (Fig. 1 & 2.)

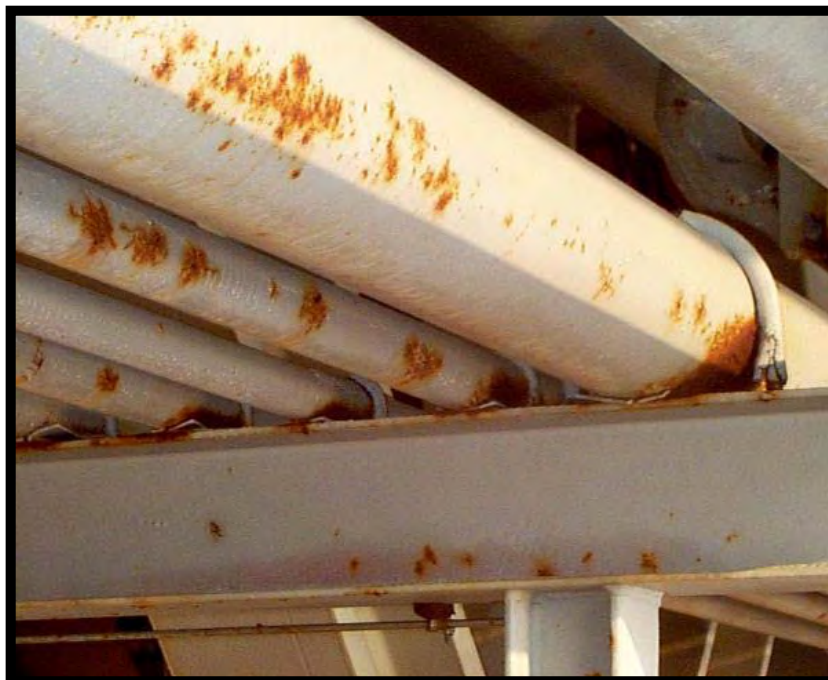
Figure 2. U-Bolt Stabilized Beam Supports

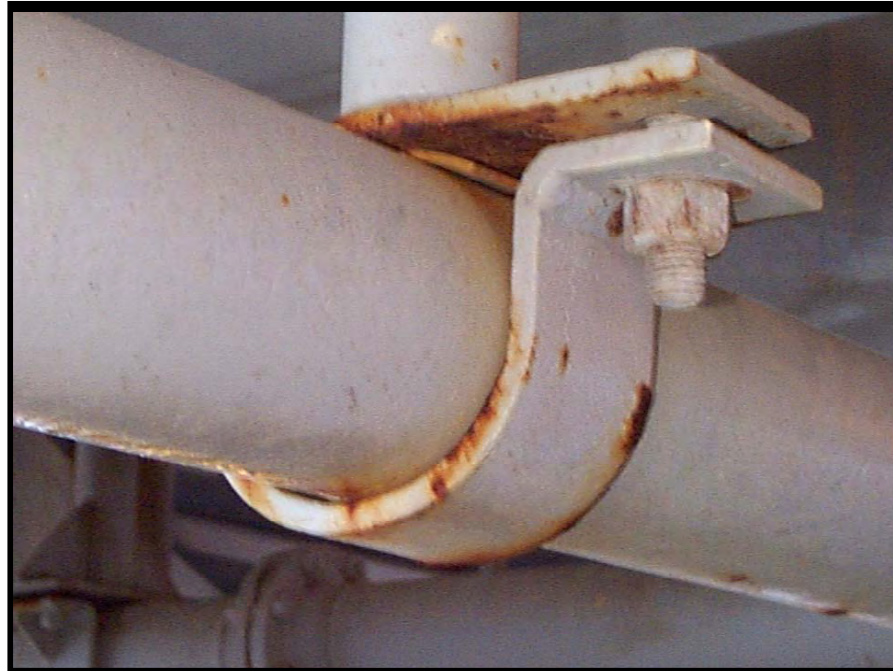
Figure 3. Typical Half Saddle Clamp

Pipe is clamped between two rolled plates, one of these plates has a structural element welded to it which attaches the pipe to the support structure. (Fig. 3 & 4.)

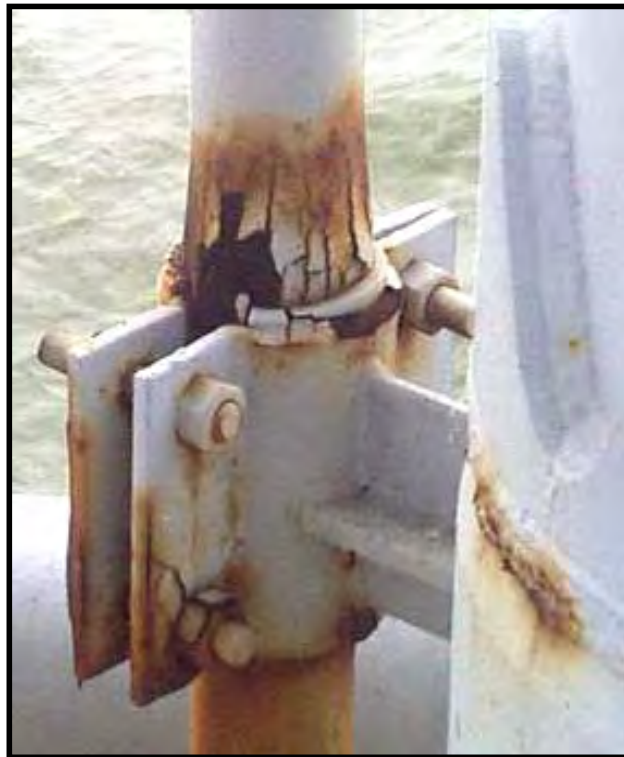
Figure 4. Full Saddle Clamp

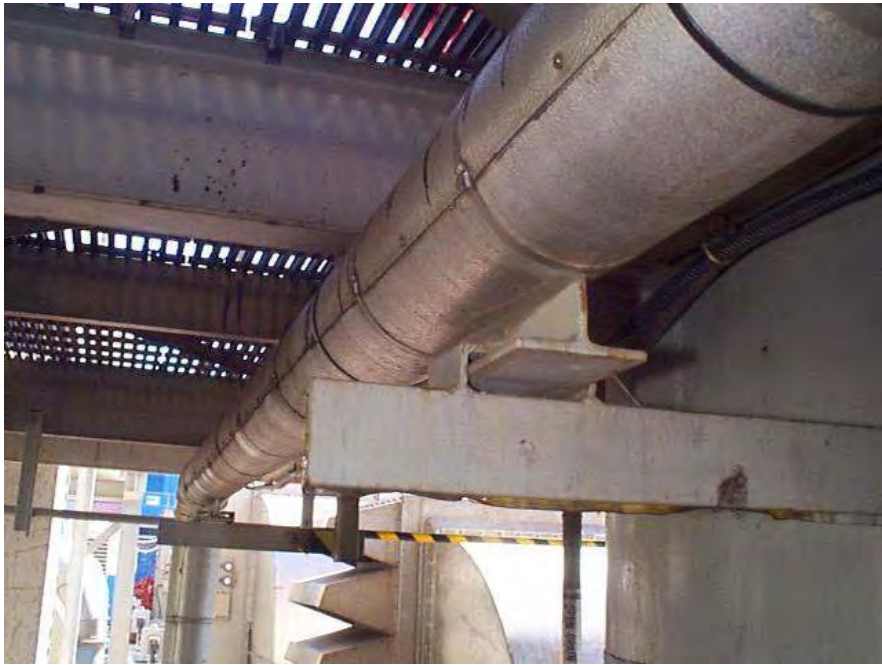
Figure 5. Typical Welded Pipe Support

This type of support involves welding a part to the pipe and then it is usually free to move at the interface to the support. There are a number of variations on this theme, this is a common approach for insulated piping systems. (Fig. 5.)

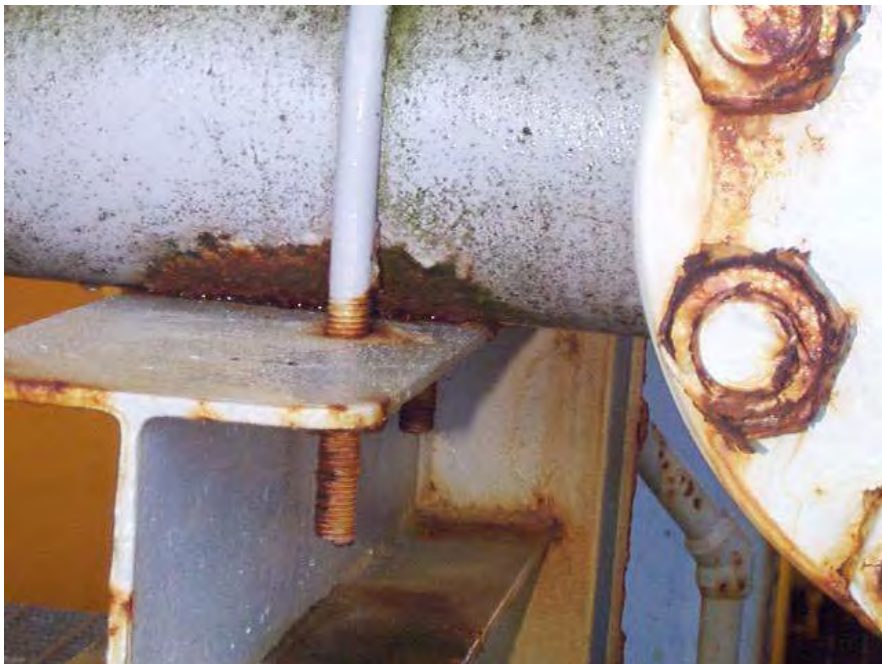
Figure 6. Progressive Paint Undercut Away From Initiation Site

The initial corrosion soon undercuts and spreads (Fig. 6.) Soon the whole support area is bare steel.

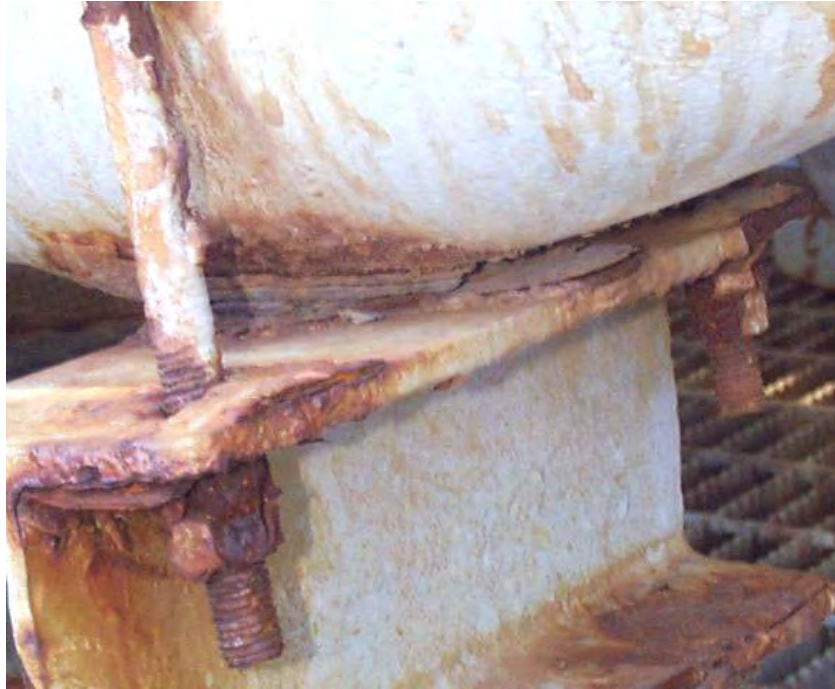
Figure 7. Advanced Crevice Corrosion

From this point on the crevice corrosion driven by differential aeration takes over from the general corrosion mechanism that initiated the corrosion. As corrosion products build they further restrict oxygen diffusion and the oxygen concentration gradient gets steeper. Pitting now becomes the main problem with corrosion rates acceleration by an order of magnitude. (Fig. 7.)

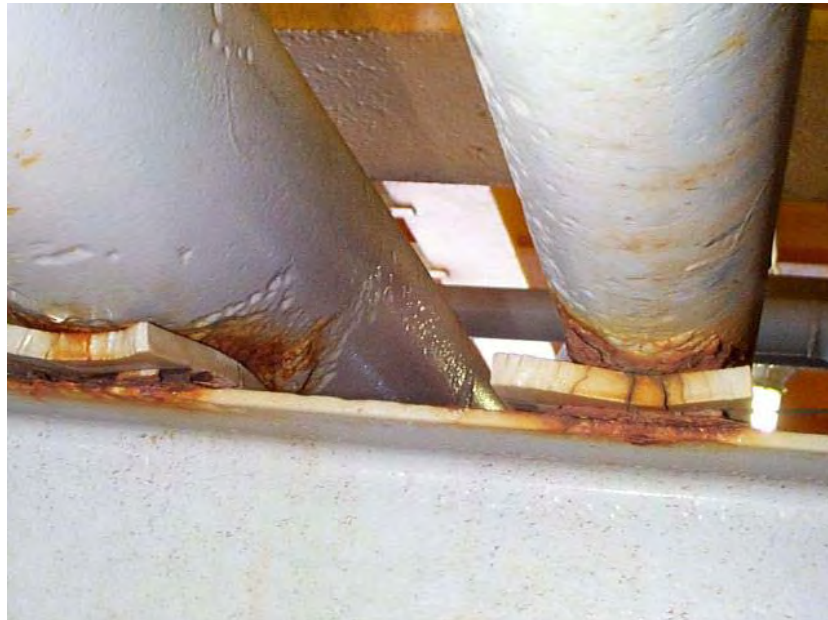
Figure 8. Rubber Pads Accelerate Crevice Corrosion

As previously stated, it was thought that the metal-to-metal contact was the main problem, hence if this were eliminated the problem would also be eliminated. The use of rubber pads of some type has been and is still thought to solve the problem. Not true (Fig. 8.) In fact, rubber pads under pipes do a wonderful job of reducing the life of the pipe. The crevice that was formed without the rubber pad is mild in comparison to the new crevice, which now has the ability to actually suck water in (by capillary action). Not only is it better at getting water in, it is better at holding it, since air circulation and natural evaporation is eliminated. The situation is further worsened by the length of the crevice which allows an oxygen concentration gradient to go from full natural concentration to anaerobic in a few centimeters.

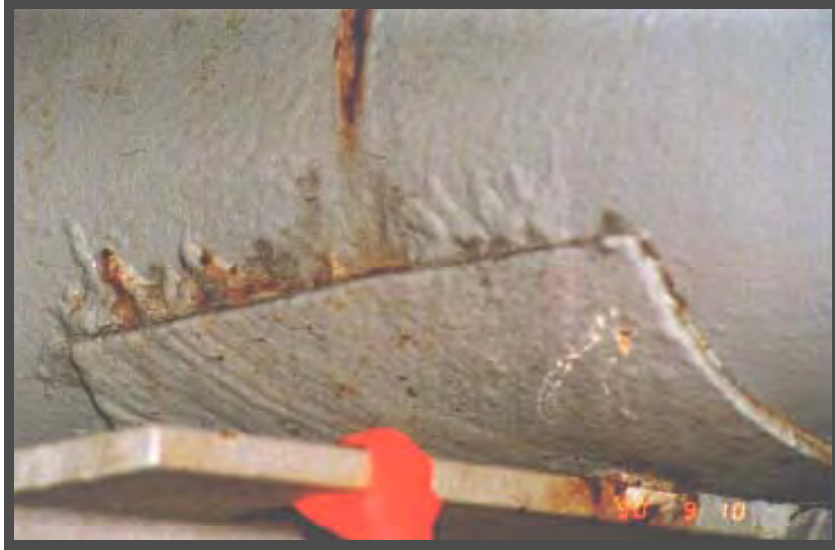
Figure 9. Fiberglass Contoured Pads Still Risk Crevice Corrosion

Contoured pads attached to the pipe at support points (Fig. 9.) Obviously another attempt to eliminate metal to metal contact. This is better than the rubber pads but still allows a crevice to be formed at the pipe surface.

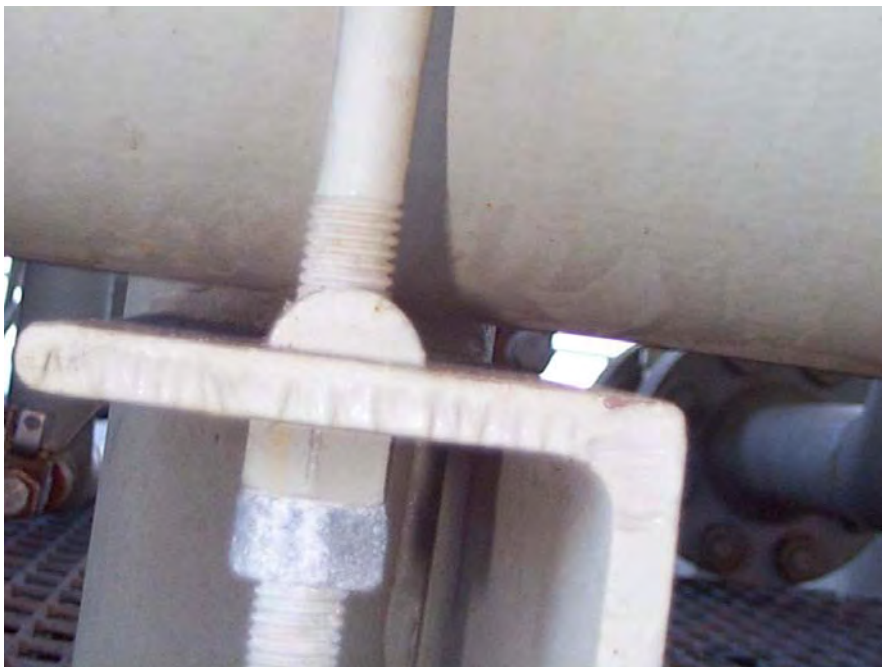
Figure 10. The Half-Round Pipe Support Interface

The half round, high strength thermo-plastic rod (Fig. 10), meets all of the above requirements. The half round configuration minimizes the crevice at the pipe and allows no water accumulation. The standoff provided allows easy inspection and maintenance at the support. The metal-to-metal contact is eliminated, and if used with an insulated bolt (Fig.11), the pipe can be totally isolated from the support structure. The low cost material has been selected and configured to optimize compressive strength while exhibiting very low creep, excellent u.v. stability is also a material feature. The material can be deployed as a continuous dressing to the top of a pipe support beam (Fig.12) , or can be integrated with a stabilizing U-bolt (Fig.13). Either way allows cold work installation for new construction or retrofit applications.

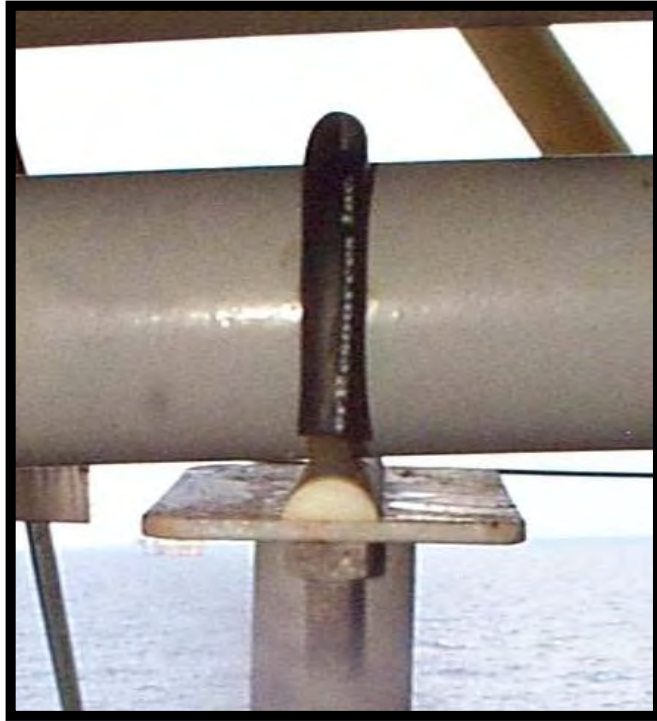
Figure 11. Rod Installed With Polyolefin Sheathed U-Bolt

When using U-bolts it is important to apply a polyolefin sleeve over the shank of the bolt. This reduces the risk of cracking the paint film around the pipe as the bolt is torqued down. The olefins provide the right combination of hardness and durability to protect the pipe paint but avoid setting up a capillary crevice around the circumference of the pipe.

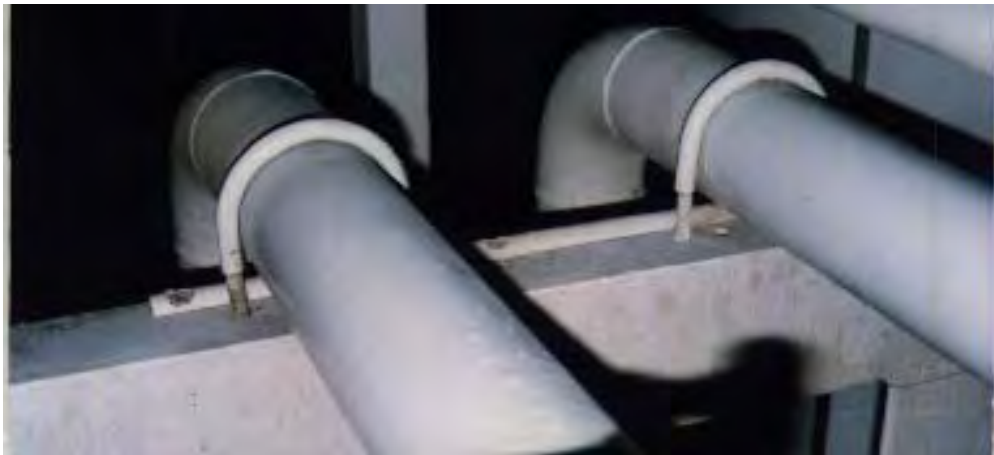
Figure 12. Rod Installed as Beam Dressing

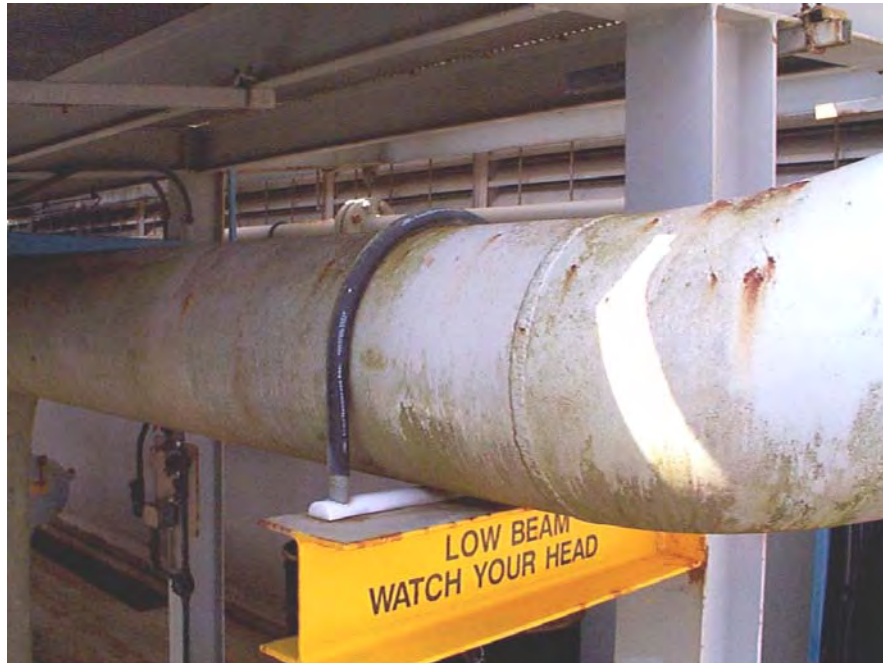
Figure 13. Typical Rod – U-Bolt Stand Alone Support

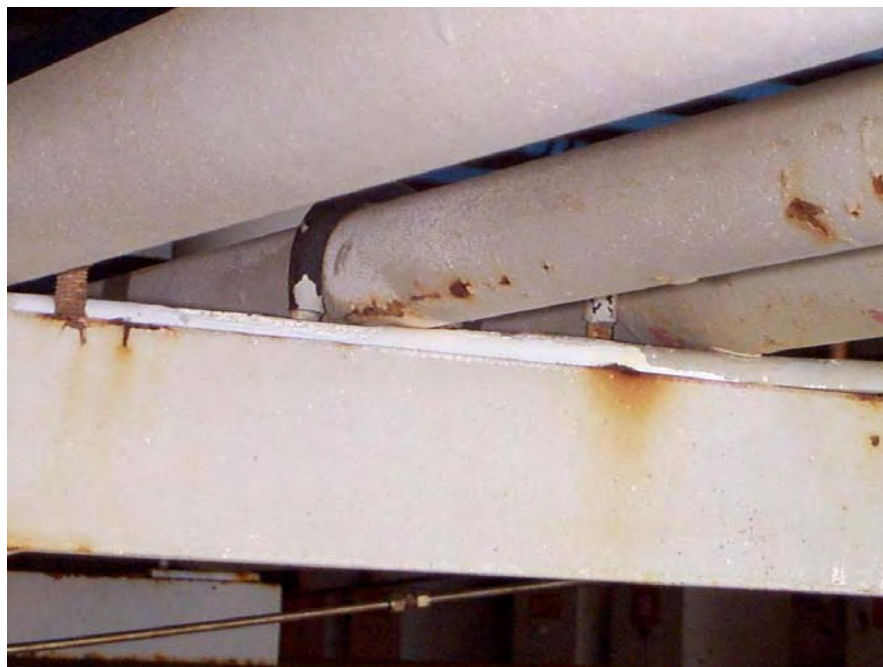
Figure 14. Beam Dressing Supports After 13 Years Offshore

The system described above was first introduced in the mid eighties, at this time there are literally thousands of offshore structures worldwide using this system. The first platform to be completely fitted with the material was installed in the Gulf of Mexico in 1989, a recent re-inspection in 2002 revealed no corrosion at any pipe support points, and no degradation of the material, some pictures are attached showing the pipe support condition after 13 years offshore (Fig. 14 – 16).

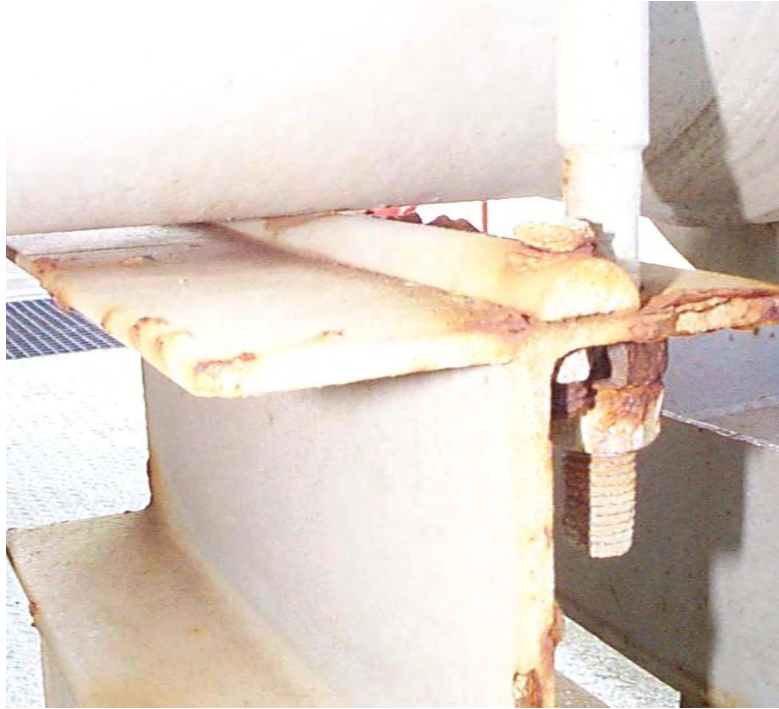
Figure 15. Rod in Place Under Pig Launch Barrel – 13 Years

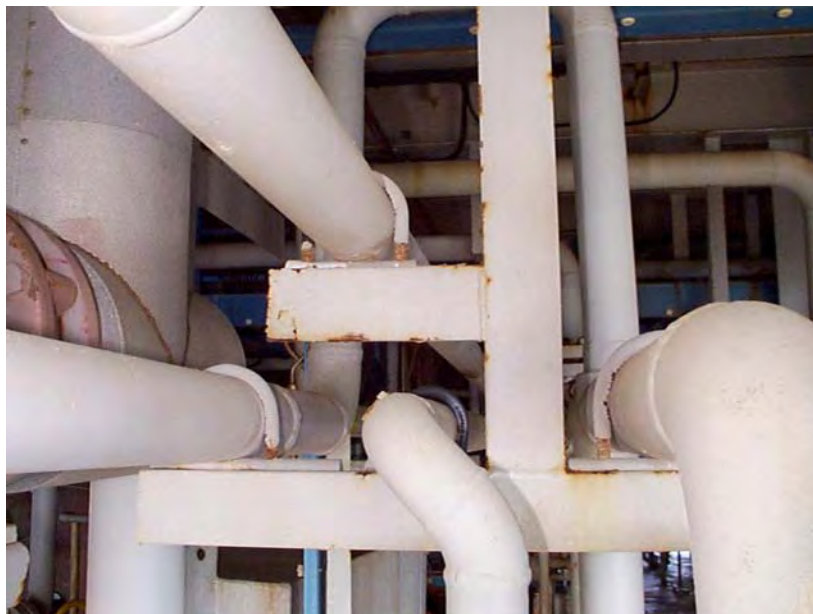
Figure 16. More Rod Bolt Combinations 13 Years Offshore

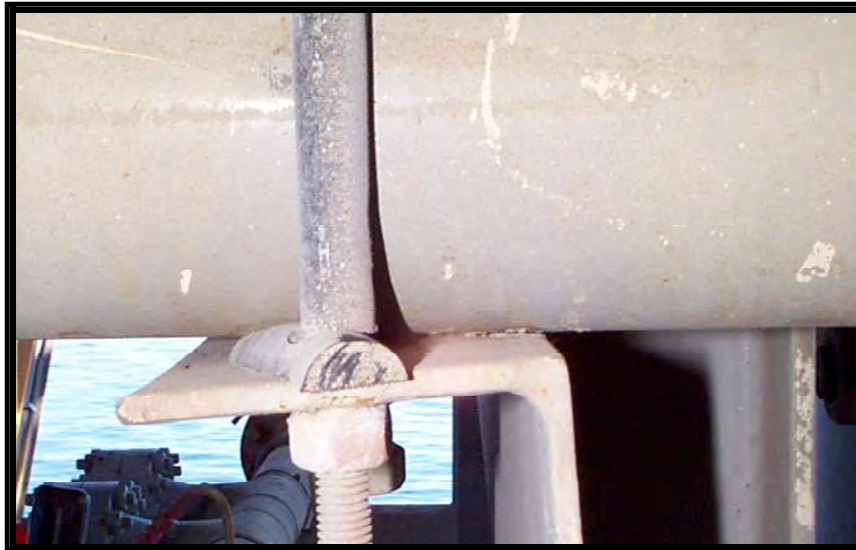
Figure 17. Low Grade Material Copies Crush Under Load

As one would expect with such an apparently simple solution, there have been many attempts to copy. This usually results in an unsatisfactory result, as most of these materials do not possess the required properties. The materials will usually crush under the load (Fig. 17) or will creep with time causing the support to loosen (Fig.18). In either case the crevice control and desirable properties are lost.

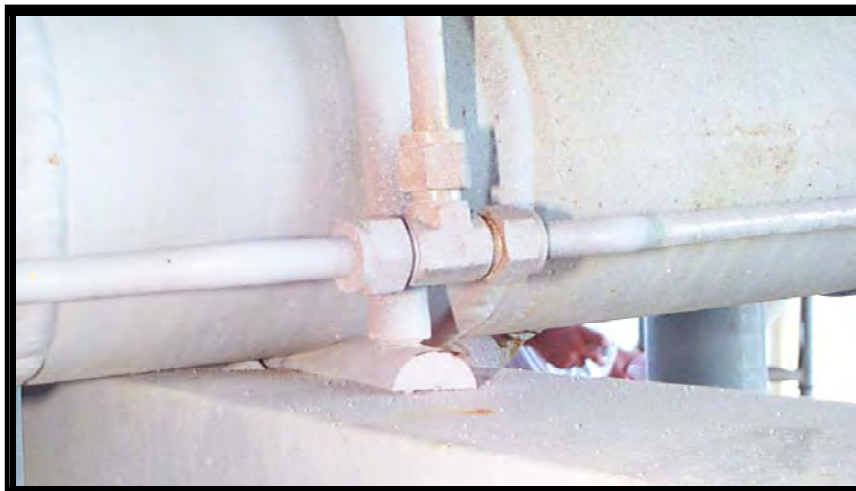
Figure 18. Some "Look Alike" Materials Creep with Time

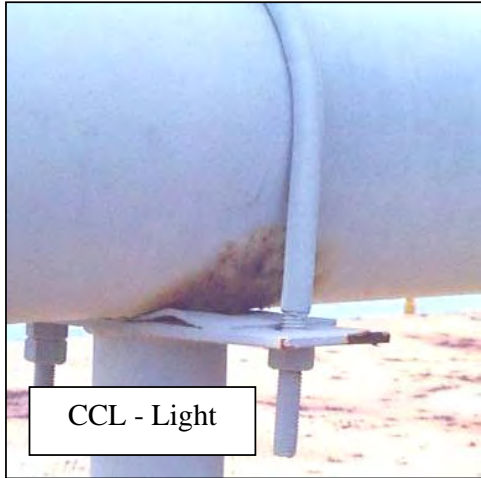
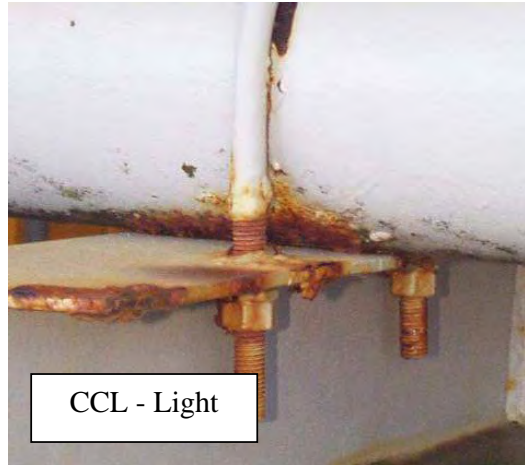
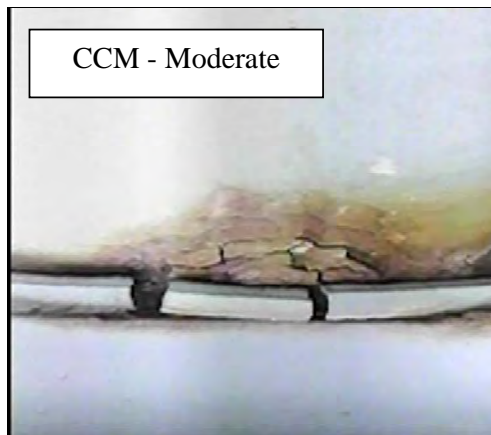
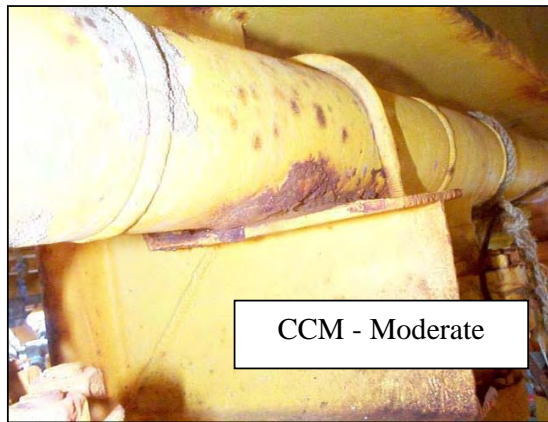
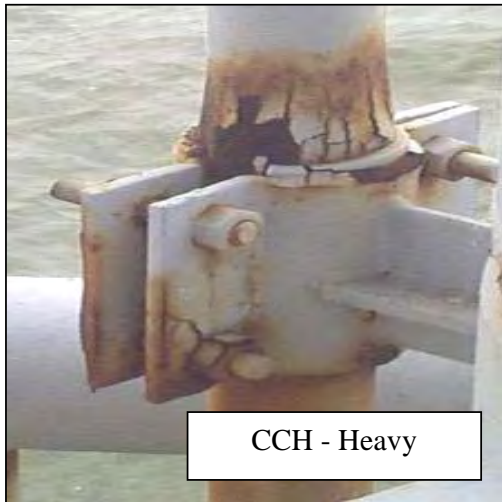
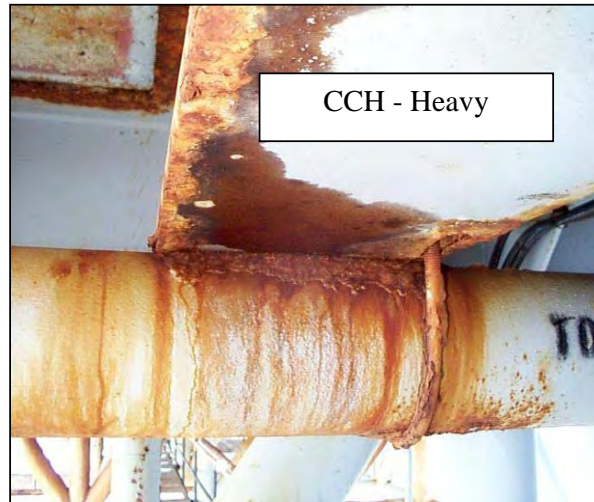
Figure 19. Comparison of Crevice Corrosion Severity at Pipe Supports

The corrosion that we are looking for is crevice corrosion as opposed to general corrosion. This corrosion is then graded in three levels, light moderate and heavy. Definitions used to define these are as follows:

CC-L (Light Crevice Corrosion) – Corrosion products visible but no evidence of layered scaling.

CC-M (Moderate Crevice Corrosion) – A single layer of corrosion scale is visible at the edge of the crevice.

CC-H (Heavy Crevice Corrosion) – Copious corrosion product leaching and visible multi-layer corrosion scale is visible.

When investigated more closely, the CC-H situations normally show a wall loss at the deepest pit of >40%. A visual guide is provided for inspectors, to assist in making the correct call (Fig. 19).
