FIELD CASE STUDIES: CATHODIC PROTECTION SYSTEMS

NEW CONCEPTS IN LIFE EXTENSION FOR BROWNFIELD OFFSHORE ASSETS

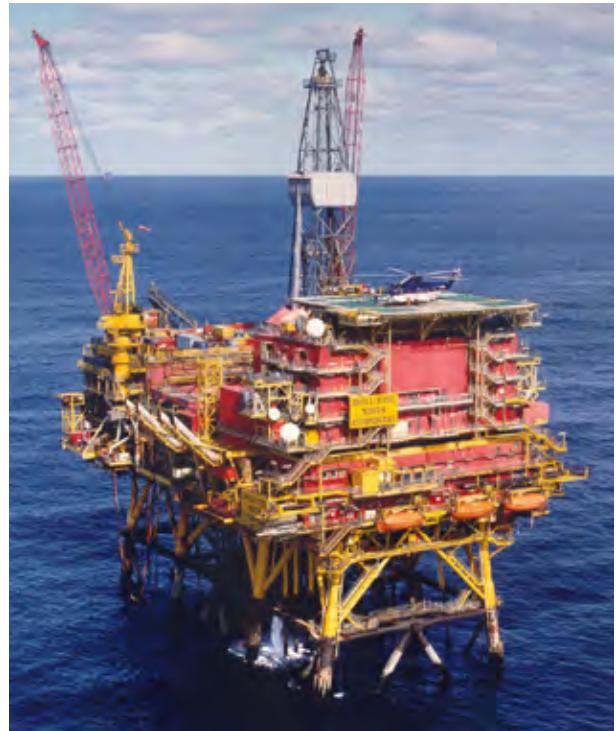
FIG. 1: A 20-YEAR LIFE EXTENSION WAS NEEDED
The North Sea platform is in 160 meters of seawater

Structure - The structure is a fixed steel drilling / production platform located in 160 meters of water in the northern North Sea [Fig. 1]. The platform was installed in 1980 and was fitted with sacrificial aluminum anodes. The platform is still viable and serves as a critical hub for major fields in the area. Based on this utility, the operator required a 20-year life extension. A survey showed large areas of the structure to be inadequately protected with readings in the range of (-) 0.680 V vs. Ag/AgCl sw. recorded on parts of the structure. It was determined that the large eight-legged structure required a retrofitted cathodic protection current capacity of 7500 Amperes.

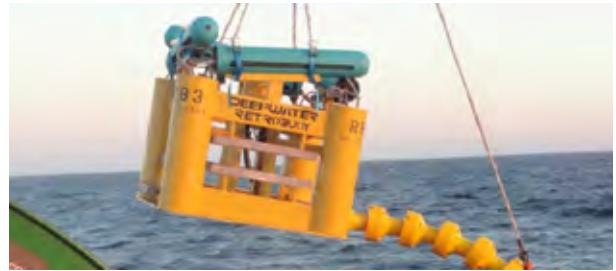
FIG. 2: 950-AMPERE ICCP BUOYANT ANODE SKID
This is one of eight that were installed

System selection - Project costs in the North Sea are dominated by offshore construction costs, so a solution that minimized boat and ROV time was critical. The system selected was a newly-modified, high-capacity version of a buoyant anode system that has been used on many previous projects. The new anode sleds [Fig. 2] each had a current rating of 950 Amperes. Eight sleds were deployed at various locations on the seabed around the base of the structure, making this the largest-capacity retrofit deployment of ICCP on a single structure. It is worthy of note that the eight installations replaced the 900-plus that would have been required for the sacrificial anode option.

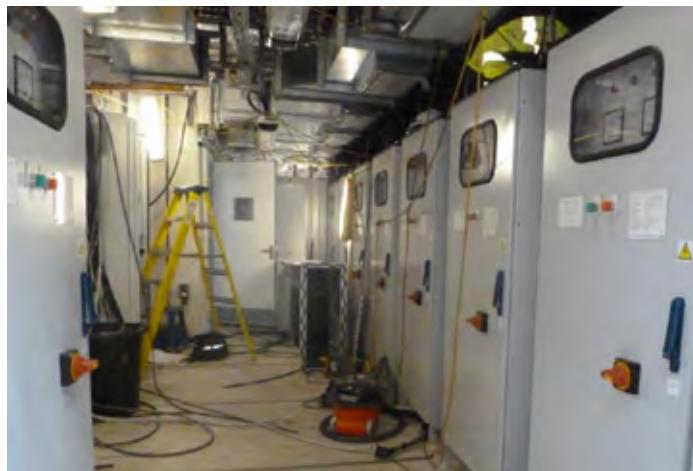
FIG. 3: THE POWER UNITS

570 KVA-rated power units in their custom container; interior view at left, exterior to the right.

Power units - The power units for such an installation require 570 KVA. Normally, we would use outdoor oil-immersed transformer rectifier equipment, but for this current rating, the oil tanks' size would have been prohibitive because deck space was at a premium. It was decided to use air-cooled thyristor-controlled units housed in ventilated custom-built containers, which optimized the equipment's footprint. [Fig. 3].

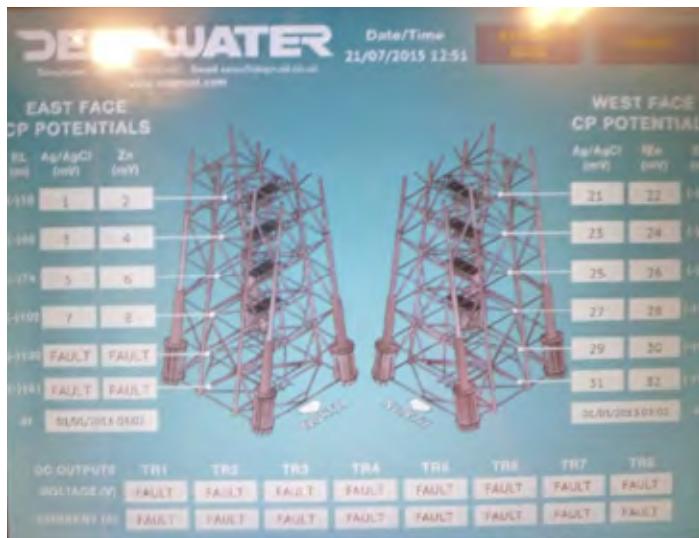
FIG. 4: THE MONITORING SCREEN
Shows location, East and West faces of 12 monitors

locations in two vertical rows on either side of the structure [Fig 4]. The bluetooth wireless transceivers were located on ROV-installable clamps [Fig 5]. The clamps were fitted with a standard dual-element reference electrode [Fig 6]. The monitoring system can send data unit-to-unit subsea and then transmit through the air-water interface. It is also possible to communicate with the monitors using an ROV. It was necessary to clean heavy marine growth from the structure so the ROV could install the monitors, and this was achieved quickly and efficiently using a brand-new, ROV-mounted flexible cleaning system [Fig 7]. It took just 4 days to install the 12 monitors.

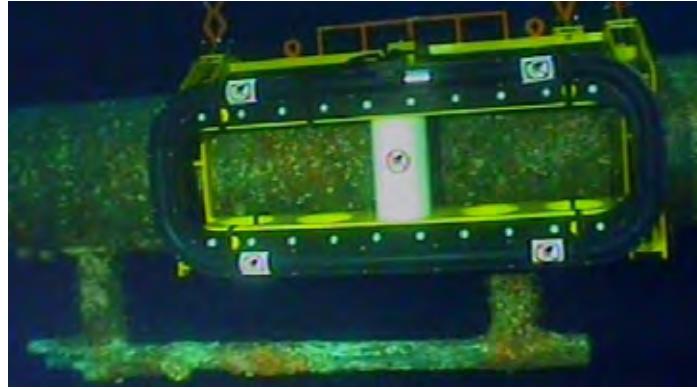
FIG. 5: THE ROV-INSTALLED WIRELESS MONITOR

Note the depleted original anode at bottom.

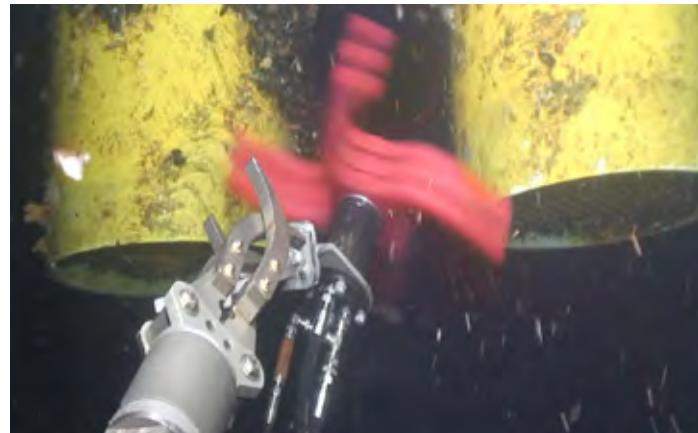
FIG. 7: ROV FLEXICLEAN SYSTEM
Reduces cleaning time for subsea installations

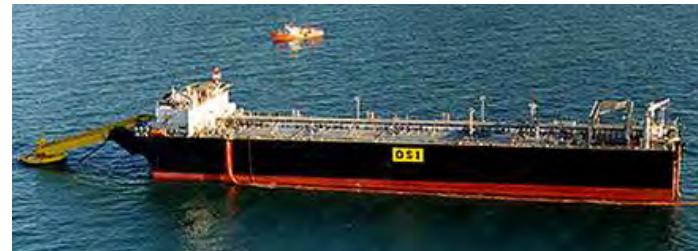
FIG. 8: OFFSHORE FLOATING STORAGE INSTALLATION
This FSO in the Irish Sea requires a 15-year life extension

The structure – In this case, the structure is a floating offshore storage and offloading installation (FSO) located in the Irish Sea in just 30 meters of water [Fig. 8]. The front of the vessel is connected to a catenary-arm mooring buoy (CALM) that allows 360-degree rotation of the hull (weathervaning). It had a conventional marine ship hull ICCP system that was installed in 1996, began to fail around 2006, and by 2012 was unable to maintain protection. The operator required a life extension until 2028 (15 years). Based on operational records and offshore current requirement testing, it was deemed that 300 Amps of retrofitted cathodic protection capacity would be adequate.

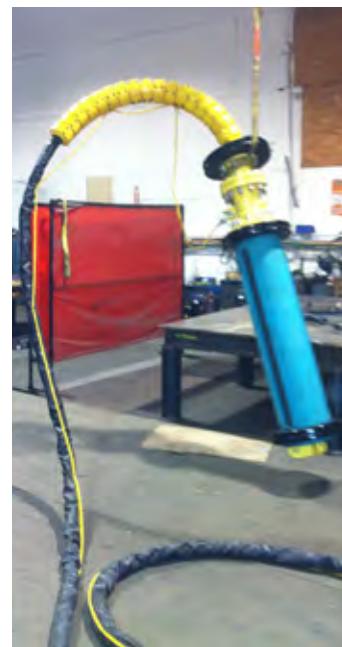
FIG. 9: SUSPENDED ANODE MODULE
Uses balcony-mounted recovery

These provisions were accepted by the owner and a retrofittable suspended-anode module system was designed. [Fig. 9].

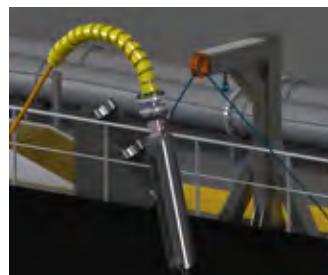
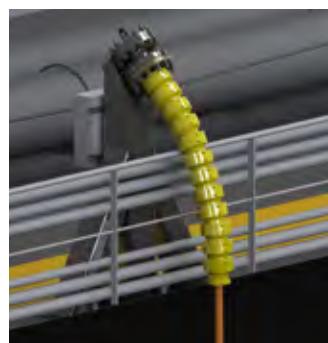
FIG. 10: THE ORIGINAL CONCEPT
Had inboard-mounted deploy/recovery

Design considerations – The original design concept used a hang-off frame and a recovery davit [Fig. 10] that were

mounted behind the railing on the vessel. This was to simplify installation and allow stowage of the anode module securely on deck in the event that green water conditions prevailed. This was eventually modified by the EPC contractor to a full overboard balcony concept, which uses one for hang-off and one for recovery. [Fig 11]. The anode system is designed to have a current rating of 150 Amperes and is set to hang about 4 meters below the keel of the vessel. The mechanical design of the anode module, power cable system and recovery tethers was highly scrutinized by the certification authorities. The recovery / deployment winch is a simple push button, and redundancy is incorporated wherever possible. Power is automatically cut to the anode as soon as the winch is activated. To track the performance of this new system, a data logger was included to monitor current and potential on the system.

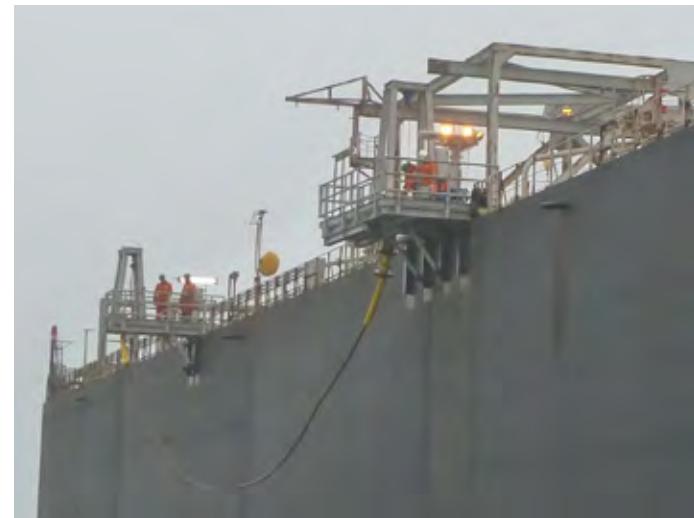
FIG. 11: THE SYSTEM INSTALLED (AFT)
Shown in the recovered position

- a) The anode system was recovered 23 times, which was an average of once every 20 days. This was more frequent through the winter of 2014.
- b) The system was out of the water approximately 30% of the time.
- c) Hull potentials were maintained in the protected region for better than 98% of the time [Fig 11] and only one region of the hull showed spikes outside protected ranges.

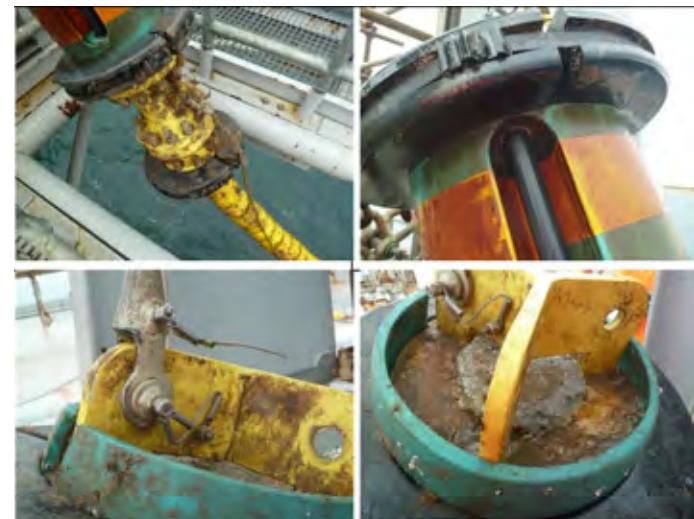
FIG. 12: HOW IT HOLDS UP
Condition of the module after 18 months in service

During the first annual inspection visit we found some localized abrasion damage to the tether rope's outer braiding, which was deemed non critical. We also noted some minor localized abrasion damage to the protective sheath on the power cable that was easily repaired. There was no visible damage to the anode module, which was functioning as designed. One redundant continuity jumper was damaged between a tether clevis and the module frame, which was quickly repaired. As expected, the sacrificial anode protecting the anode module's steel structure was lightly depleted. Pictures of one of the two modules are shown [Fig 12].

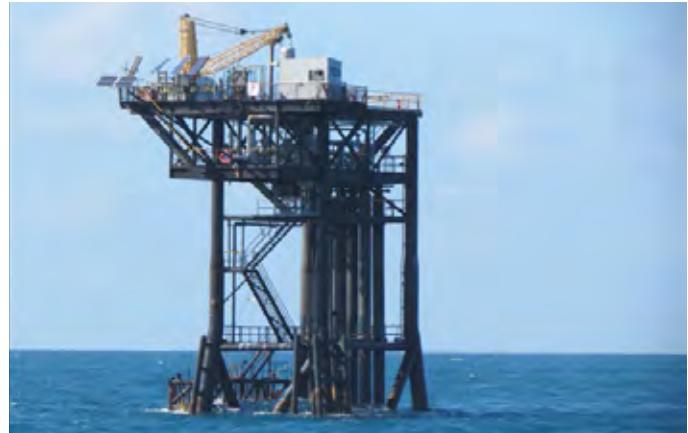
FIG. 13: WELLHEAD PLATFORM IN THE GULF OF MEXICO
The structure requires a five-year life extension

A brownfield fixed platform in 42 meters of water required a short five-year life extension ahead of a decommission decision. The retrofit was completed as part of an IRM program where inspection and repair were conducted on the same mobilization. The platform, a small four-pile wellhead structure, has six wells and is located in the Eugene Island area in the central Gulf of Mexico [Fig. 13]. With all potentials in the range of (-) 0.670 to (-) 0.680 V vs. Ag/AgCl sw, the platform was almost completely depolarized.

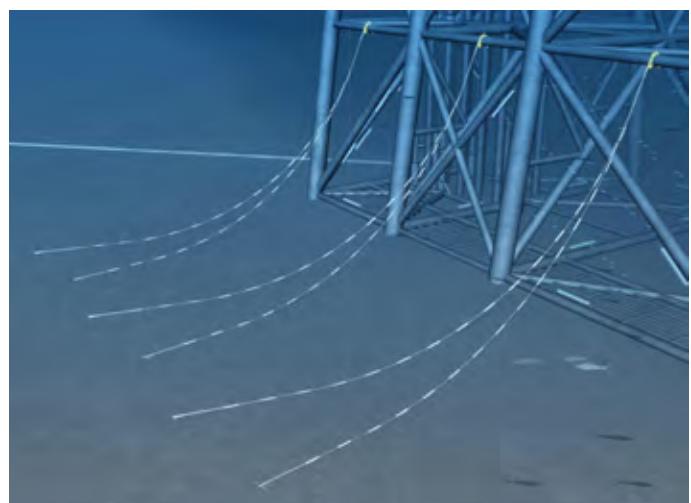
FIG. 14: LINK ANODES SHOWN IN "SKIRT LINK DEPLOYMENT"
Installed using a shallow air six-man dive crew

The water depth precluded installation of conventional diverless suspended-link anodes [1], so the decision was made to use subsea-installed links [Fig. 14]. The required current was estimated at 175 Amps, so a total of 22 links attached to 11 subsea clamps were ordered. An aluminum weight of 6750 Kg. was calculated to provide the required current for six to seven years.

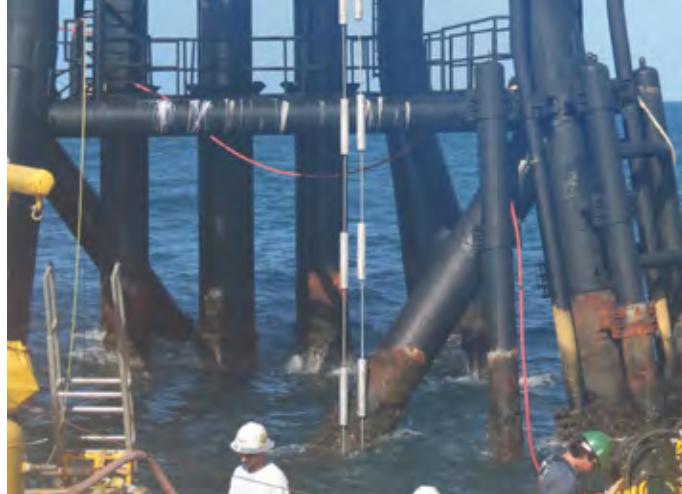
FIG. 15: SKIRT LINK INSTALLATION
The retrofit and inspections took four days offshore

The as-found inspection followed by the repair and the as-left re-inspection took four days offshore using a shallow air six-man dive crew. Some installation images are shown [Fig. 15]. Part of the scope was to record the current output from each anode string after installation so that the customer could optimize similar life extensions on other structures in the fleet. A clamp-on subsea ammeter was used to accomplish this. The results are presented [Table 1.] and show before-and-after potential measurements and the current output of each string. The current required to protect the structure came in very close to our estimate (160 Amps actual vs. 175 Amps designed).
