## RETROLINKS™ INSTALLED ON TWO PLATFORMS: GULF OF MEXICO

### Two platforms retrofit in two days total.

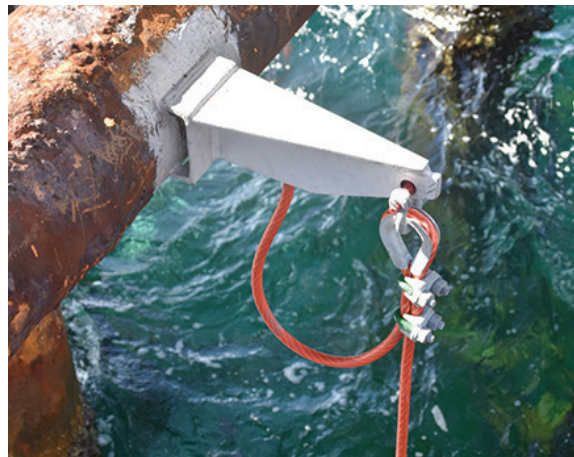
**HORIZONTAL STANDOFF**

29 of the stand-offs were horizontal weld-on and two were vertical.

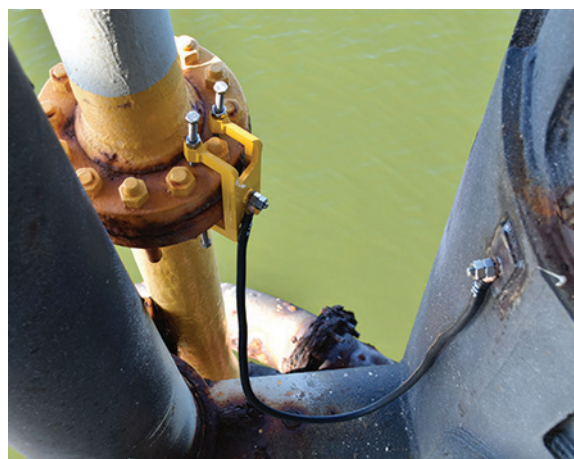
**VAMP CLAMP™ WITH BONDING CABLE**

The clamp was installed to ensure electrical continuity across the flange.

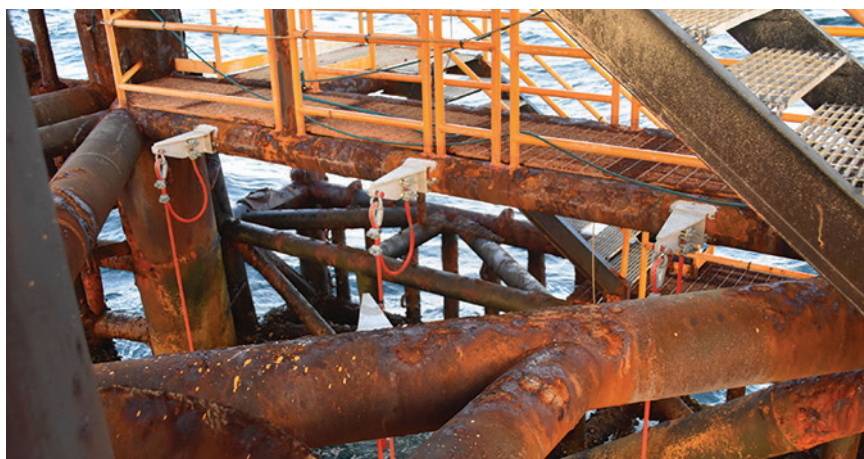
**QUICK INSTALLATION**

Each structure took just one day to retrofit.

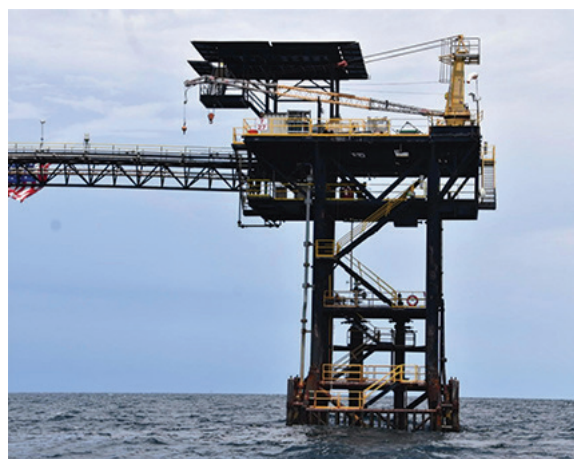
**FOUR-LEG PLATFORM**

This structure required 16 RetroLinks™

The first platform is a four-leg structure in 125 feet of water that required 16 RetroLinks™, fourteen of which were suspended from horizontal weld-on stand-offs and two more suspended from vertical weld-on stand-offs. Average maximum pre-installation potentials were -748 mV, and average post-installation potentials were -1012 mV.
