DEEPWATER

FIELD CASE STUDIES: TABU, GUNTONG, SEMANGKOK

REPLACEMENT OF DEPLETED ANODES DURING PIPELINE SURVEY CAMPAIGN IN MALAYSIA

RETROSLED ANODE SLEDS INSTALLED ON THREE UNPROTECTED PIPELINES

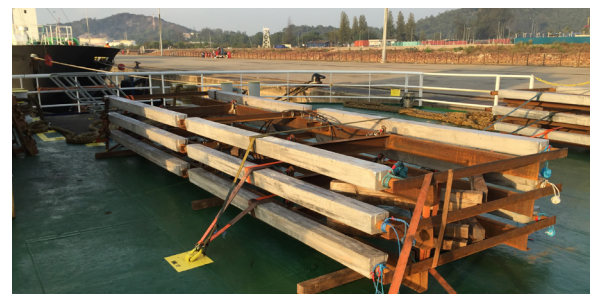
ANODE SLEDS (RETROSLEDS) ON VESSEL READY FOR DEPLOYMENT

The Retrosleds were fabricated locally in Malaysia and the RetroClamps were shipped from Houston. The Installation was performed from the vessel Atlantis Dweller using an ROV in 60 meters of water on 3 pipeline off the coast of Malaysia. The clamps and sleds were installed by ROV without removing the concrete weight coat on the pipeline. This was a first in the region. The 3 pipelines: the TABU-A to TABU-B Pipeline, the GUNTONG-A to GUNTONG-B Pipeline, and the SEMANGKOK-A to SEMANGKOK-B pipeline

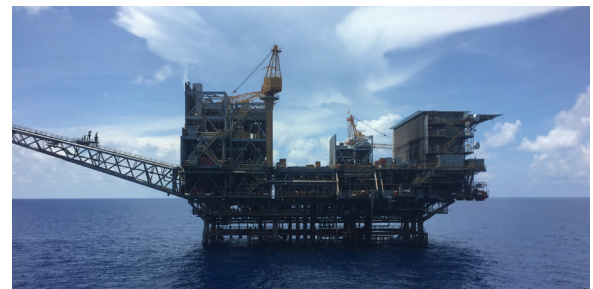
PLATFORM FOR RETROSLED REMOTE ANODE RETROFIT

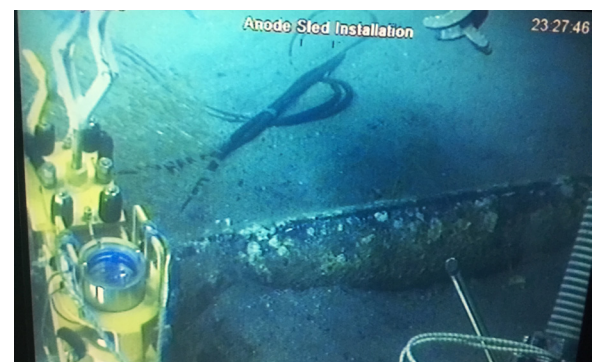
RETROCLAMP ESTABLISHES ELECTRICAL CONTINUITY BETWEEN THE SLEDS AND THE STRUCTURE. THIS CLAMP IS FITTED A FIXED MONITORING SYSTEM.
