DEEPWATER

RETROSAM™ HANGING ICCP ANODE SYSTEM INSTALLED ON FPSO: NORTH SEA

A hanging impressed-current anode system was used to retrofit Triton's failing ICCP system.

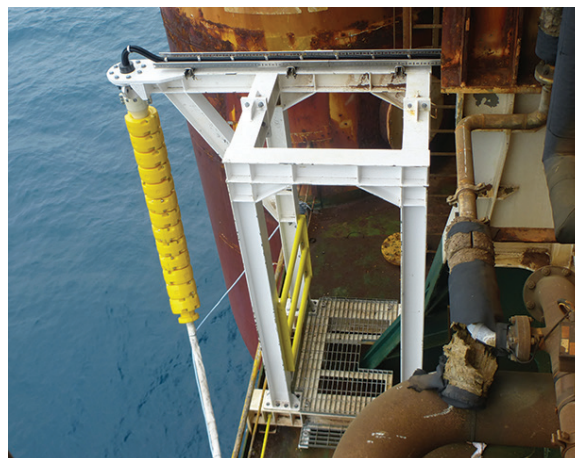
HANGING AROUND THE PORCH

The anode module is suspended from this porch during normal operations.

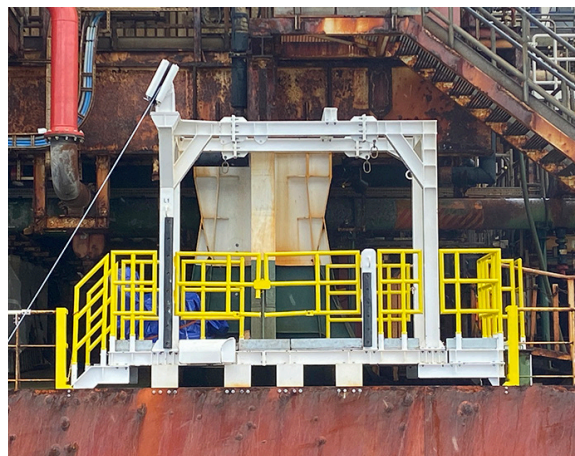
ANY PORCH IN A STORM

The anode module is hoisted aboard this porch during harsh weather.

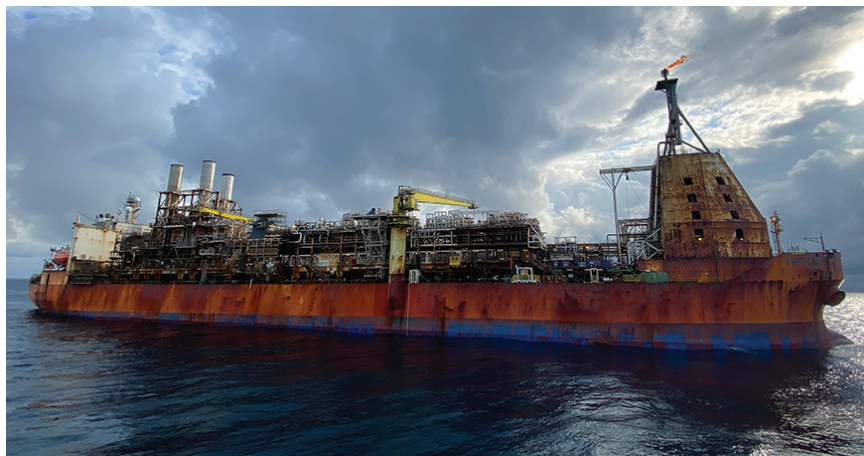
TRITON FPSO

The vessel, which sits in 90 metres of water, is 244 metres long and has a storage capacity of 630,000 barrels.

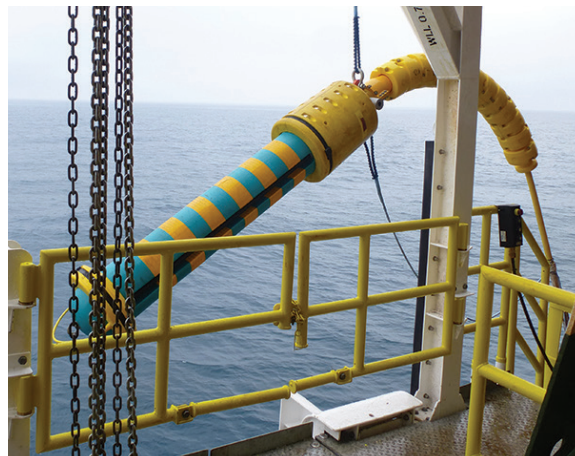
RECOVERY TIME

The RetroSAM™ while hoisted onto the recovery porch.
