## RETROLINKS™ INSTALLED ON TWO PLATFORMS: GULF OF MEXICO

### Two platforms retrofit in two days total.

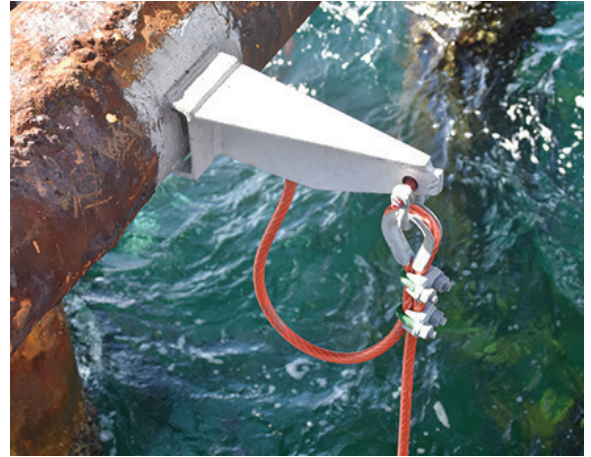
**HORIZONTAL STANDOFF**

29 of the stand-offs were horizontal weld-on and two were vertical.

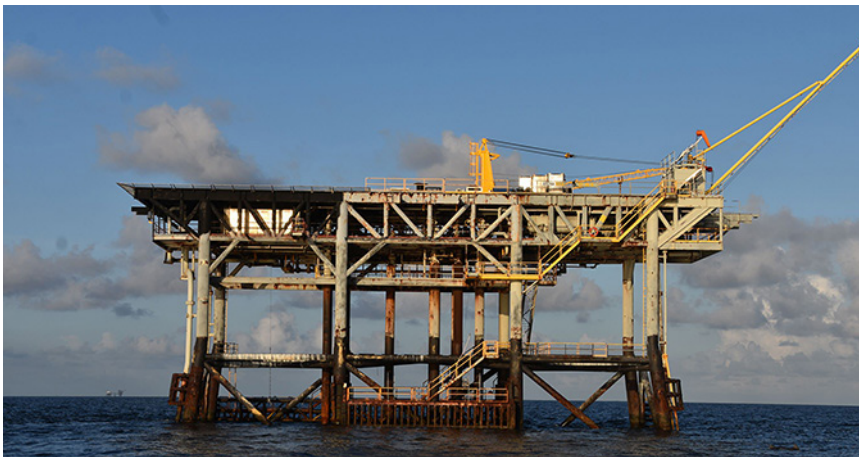
**EIGHT-LEG PLATFORM**

Its retrofit required 15 RetroLinks™.

The second platform is an eight-leg structure in 57' of water that required 15 RetroLinks™, all of which were suspended from horizontal weld-on stand-offs. Average maximum pre-installation potentials were -658 mV and average post-installation potentials were -855 mV. A VampClamp™ with a bonding cable attached to one of the legs was installed on a riser flange to provide electrical continuity with the pipeline and structure. Most links required only about a half-hour each to install; installation took one day for each platform.

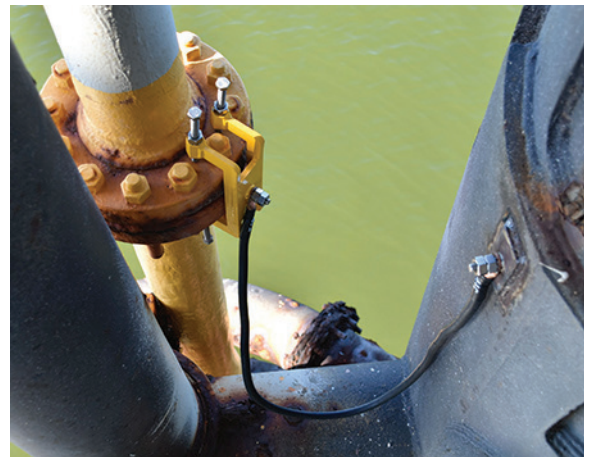
**VAMP CLAMP™ WITH BONDING CABLE**

The clamp was installed to ensure electrical continuity across the flange.

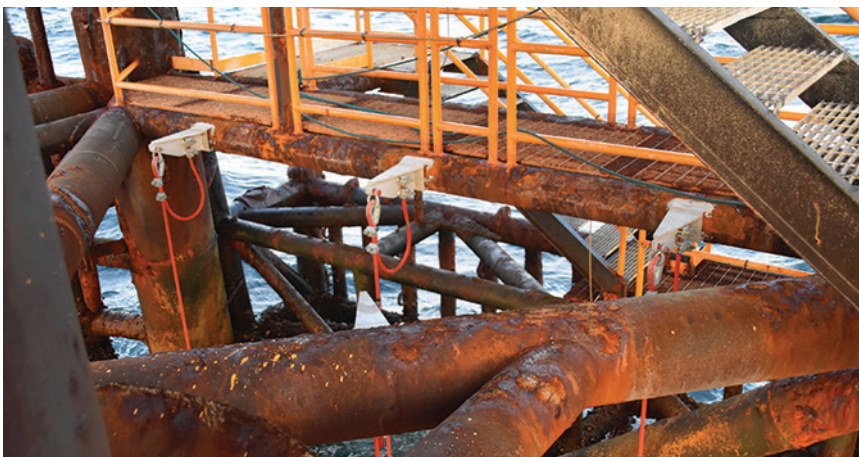
**QUICK INSTALLATION**

Each structure took just one day to retrofit.

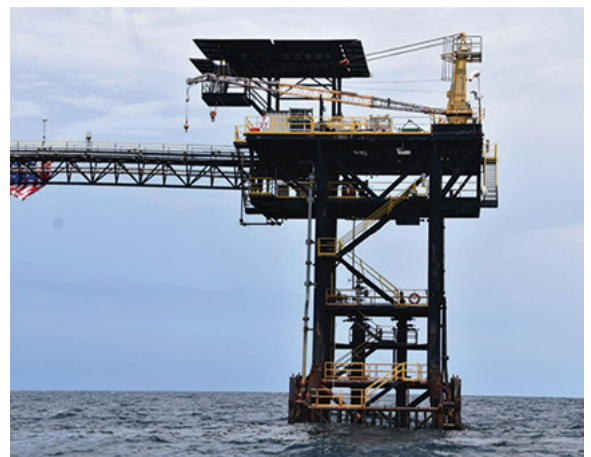
**FOUR-LEG PLATFORM**

This structure required 16 RetroLinks™

The first platform is a four-leg structure in 125 feet of water that required 16 RetroLinks™, fourteen of which were suspended from horizontal weld-on stand-offs and two more suspended from vertical weld-on stand-offs. Average maximum pre-installation potentials were -748 mV, and average post-installation potentials were -1012 mV.
